**Enhanced Safety and Efficient Construction of Masonry Structures in Europe**

**D 7.1b Test results on the behaviour of masonry under static cyclic in plane lateral loads**

Technical University of Munich  
Department of civil engineering and geodesy  
Chair of Structural Concrete  
80290 Munich

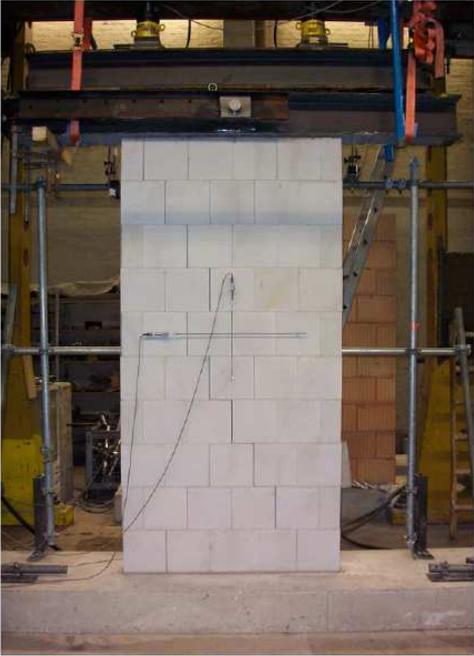
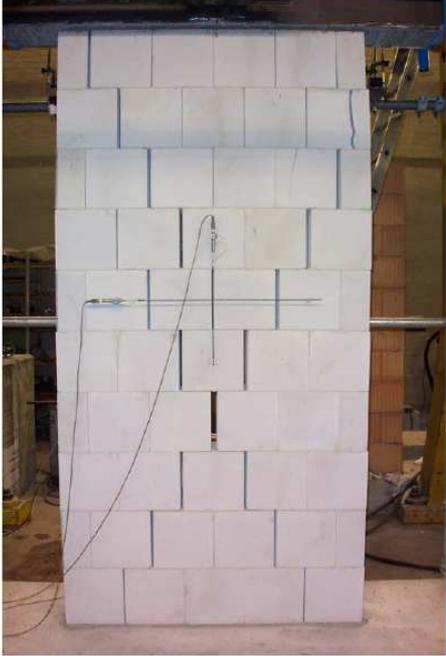
Figure 21: Crack pattern of the test specimen CS01

Figure 22: Crack pattern of the test specimen CS01

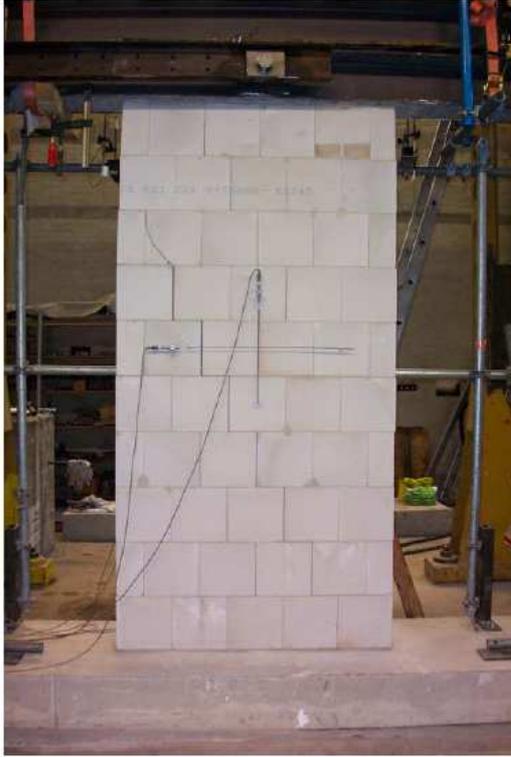
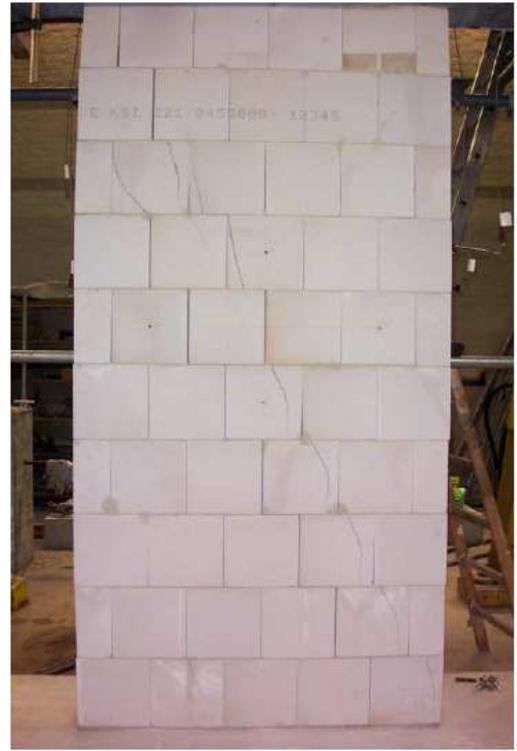
Figure 34: Crack pattern of the test specimen CS02

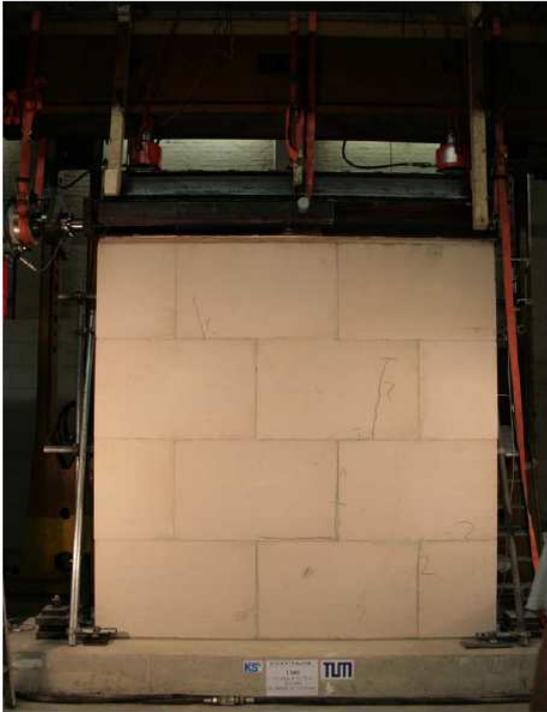
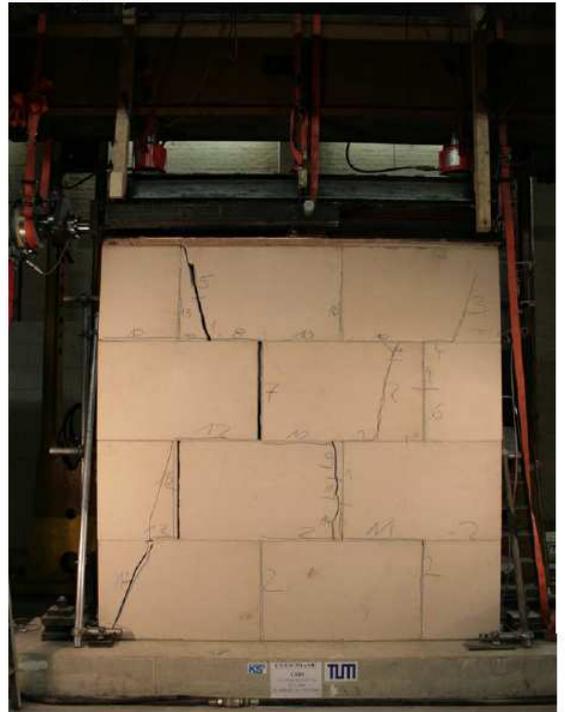
Figure 45: Crack pattern of the test specimen CS03

Figure 46: Crack pattern of the test specimen CS03

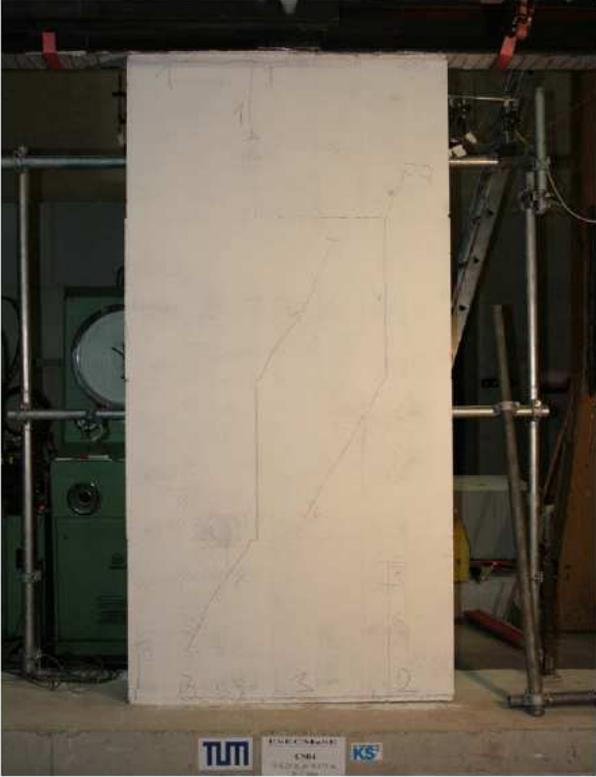
Figure 57: Crack pattern of the test specimen CS04

Figure 58: Crack pattern of the test specimen CS04

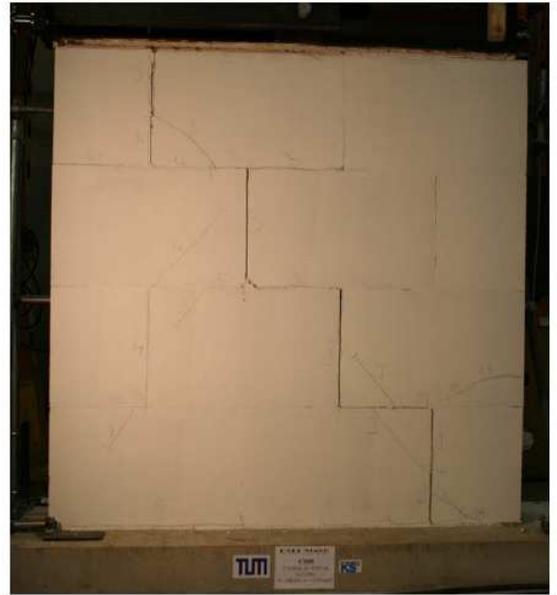
**Figure 69:** Crack pattern of the test specimen CS05

**Figure 70:** Crack pattern of the test specimen CS05

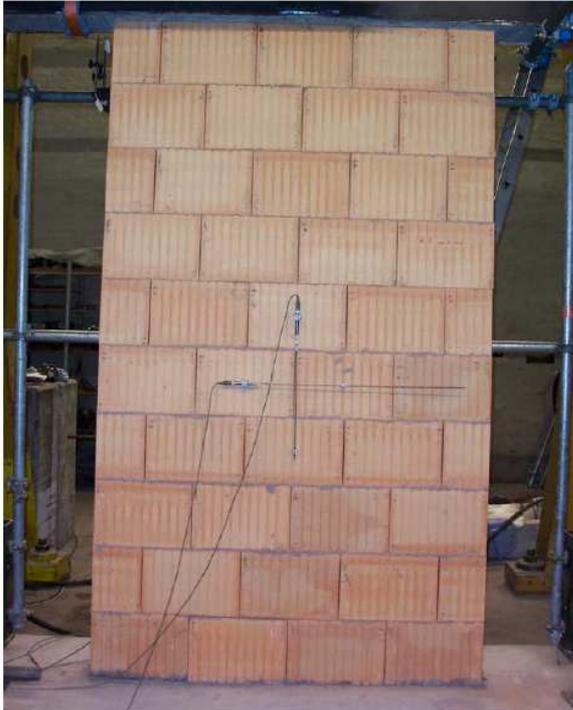
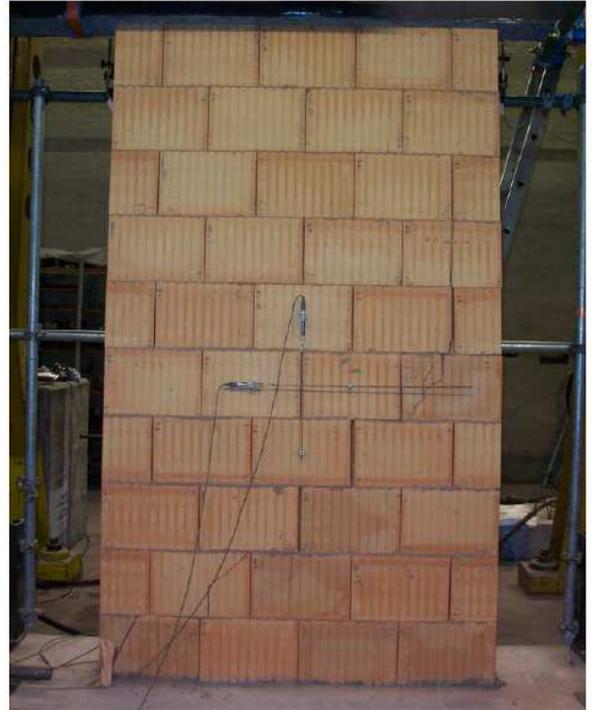
**Figure 105:** Crack pattern of the test specimen Clay01

Figure 106: Crack pattern of the test specimen Clay01
