**ESECMaSE**

**Enhanced Safety and Efficient Construction of Masonry Structures in Europe**

**D 7.1c Test results on the behaviour of masonry  
under static cyclic in plane lateral loads**

University of Pavia  
Department of Structural Mechanics  
Via Ferrata, 1  
27100 Pavia, Italy

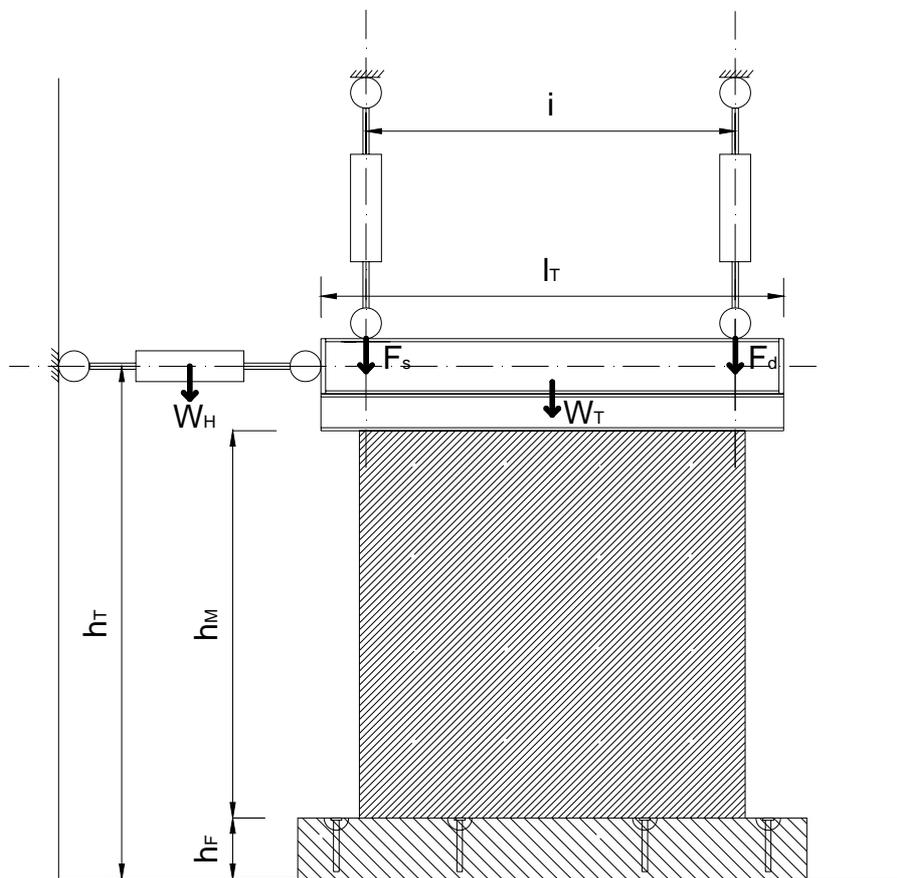
Figure 3. Scheme of the acting forces on the test set-up

The “static criterion” is obtained imposing the condition of zero bending moment at midheight of the wall. Therefore, the following expressions are implemented in the test procedure (see Figure 3):

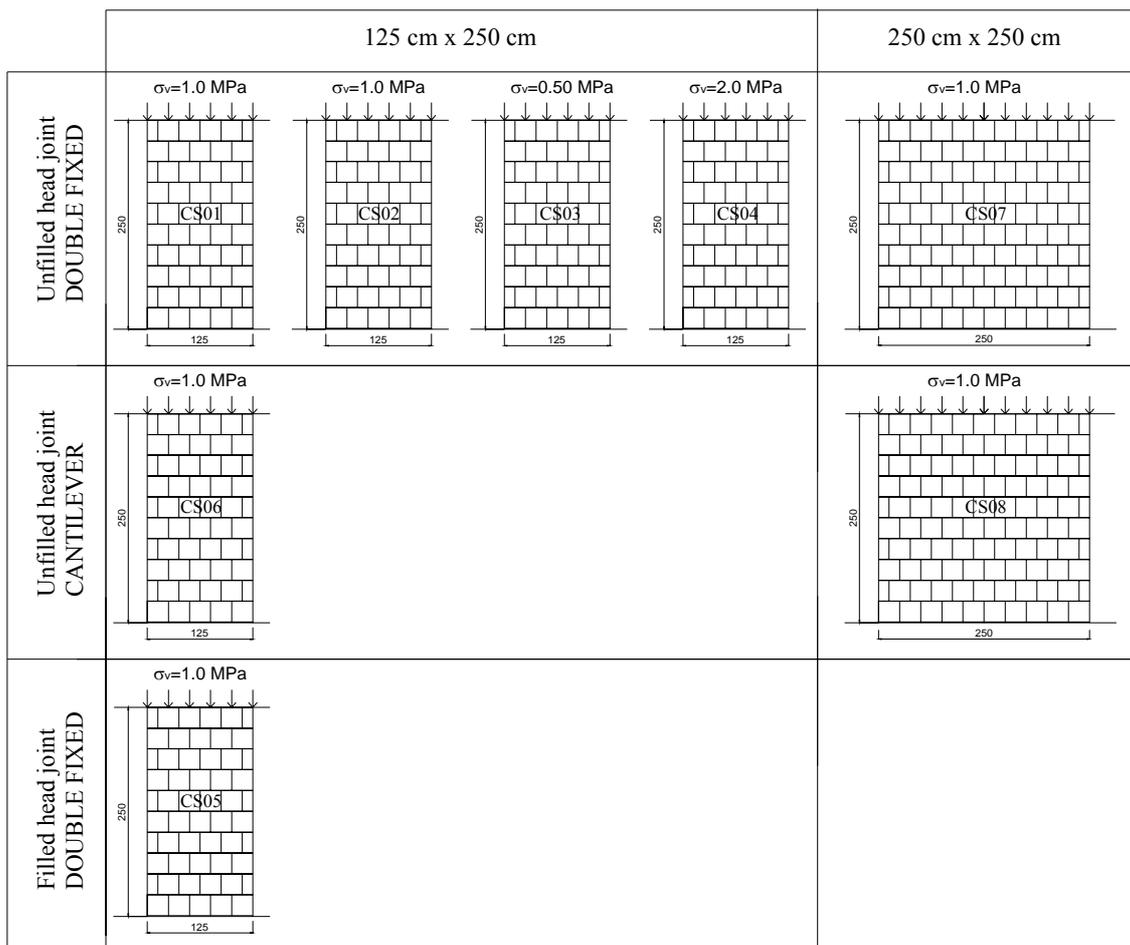
Figure 5. Matrix of the considered experimental scheme. Walls CS01-CS08

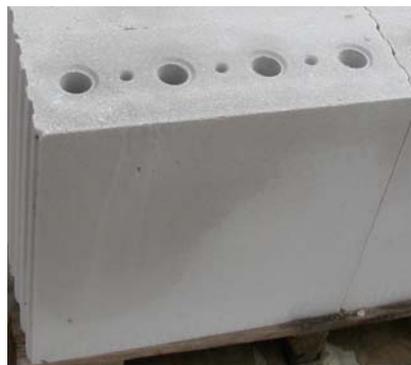
Figure 6. Type of calcium-silicate “Quadro E” unit masonry walls  
( $l \times t \times h = 498 \times 175 \times 498$  mm)

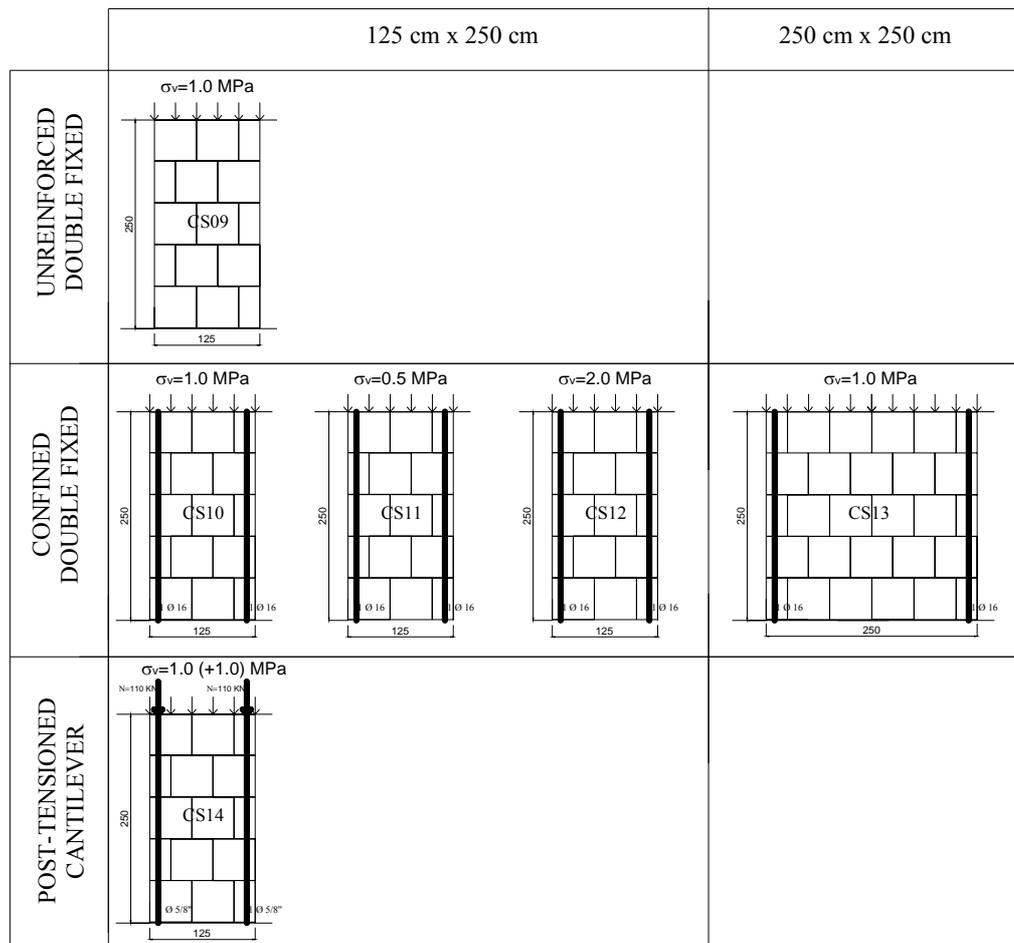
Figure 7. Matrix of the considered experimental scheme. Walls CS09-CS14

The considered experimental configurations are reported in the matrix in Figure 7.

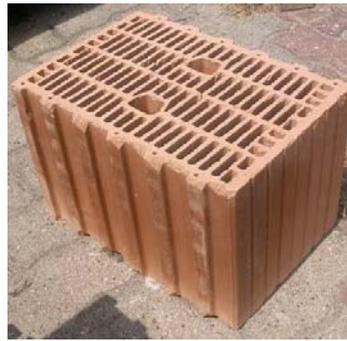
Figure 9. 365 mm thick hollow clay T+G unit used in the walls CL03  
( $l \times t \times h = 247 \times 365 \times 249$  mm)

Finally, the unreinforced masonry wall CL03 was constructed with 365 mm thick Tongue and Groove (T+G) lightweight clay units with a percentage of holes of 45% with thin layer mortar bedjoints and unfilled headjoints. The length of wall CL03 was equal to 1.00 m and the height equal to 2.5 m. The dimensions of the clay unit used were 247x365x249 mm ( $l \times t \times h$ ) (see Figure 9).

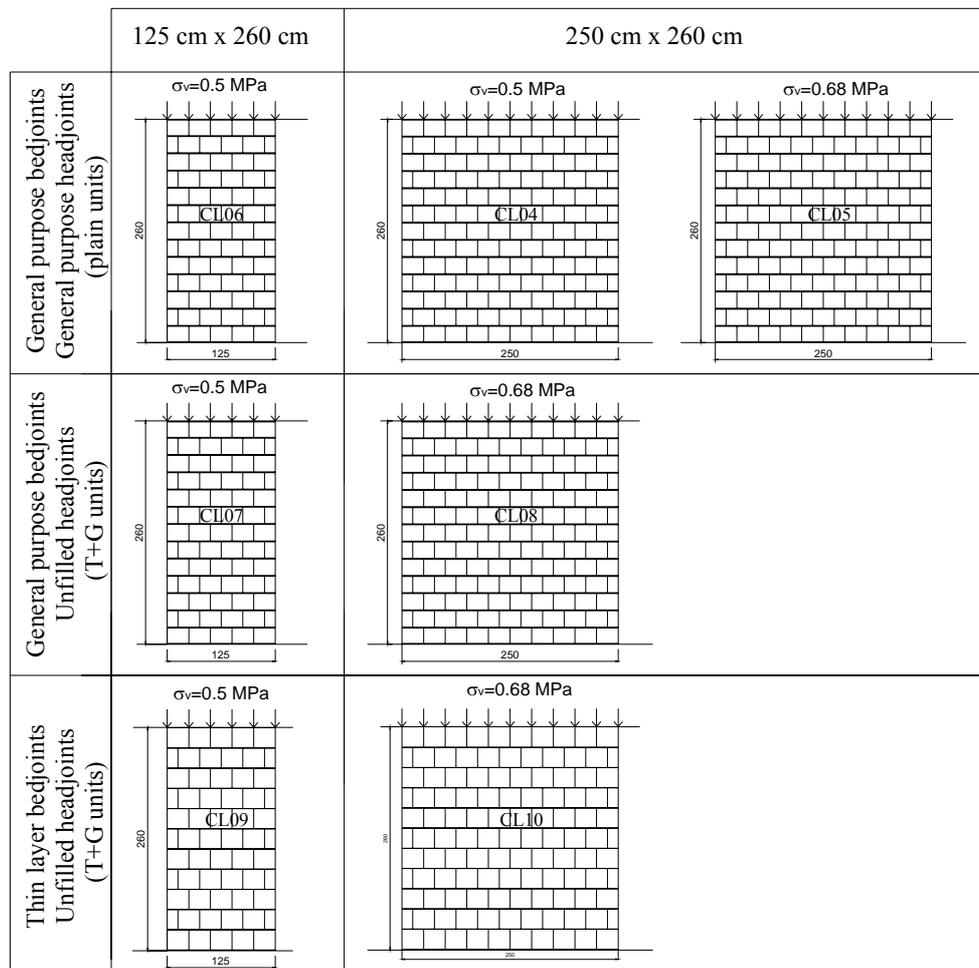
Figure 13. Matrix of the considered experimental scheme. Walls CL04-CL10

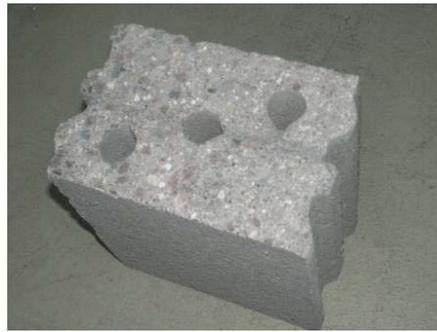
Figure 14. Lightweight aerated concrete T+G units used in walls LAC01, LAC03 ( $l \times t \times h = 247 \times 175 \times 238$  mm) and LAC02, LAC04 ( $l \times t \times h = 247 \times 175 \times 248$  mm)

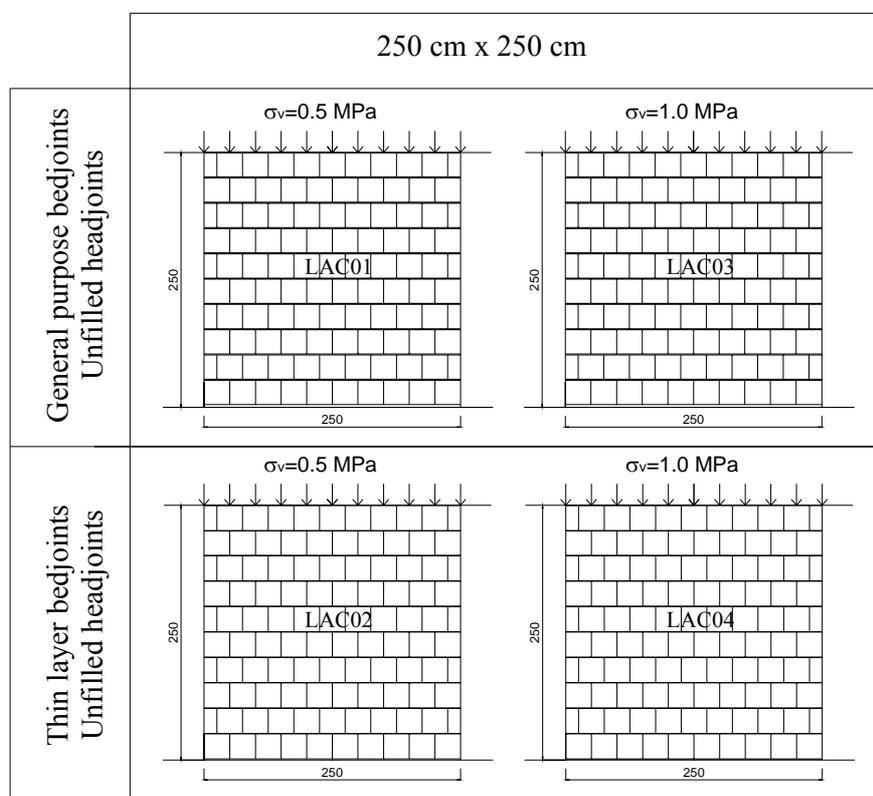
Figure 15. Matrix of the considered experimental scheme. Walls LAC01-LAC04

The considered experimental configurations are reported in the matrix in Figure 15.

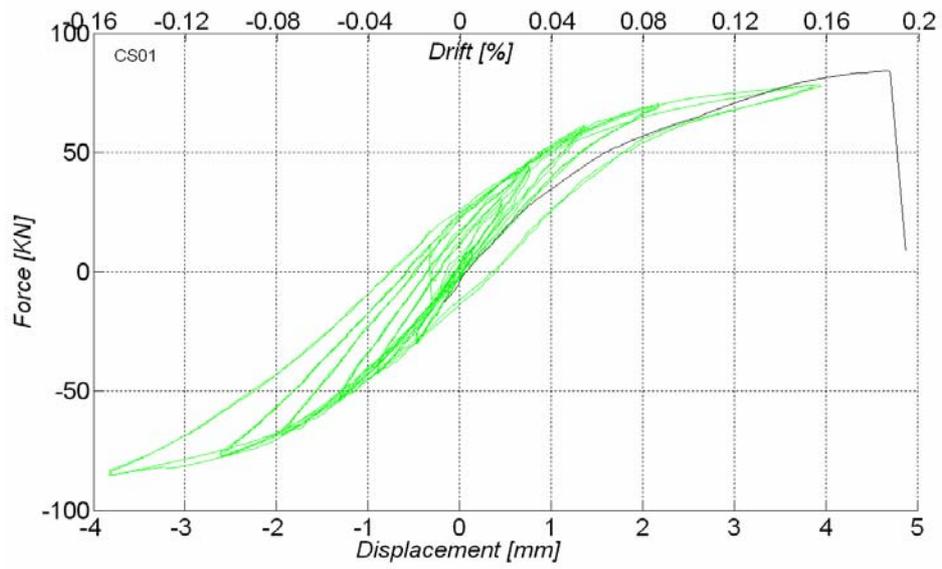
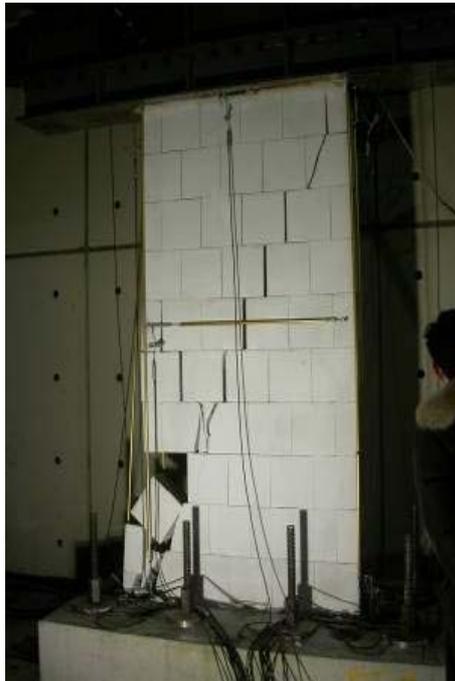
The double fixed condition on wall CS01 was applied using the “static” criterion described above, i.e. keeping the point of zero moment at mid-height of the pier. The wall failed with a sudden diagonal crack interesting both the joints and the units. Evaluating the data after the test, it appeared clear that keeping constant the point of contra-flexure at mid-height, a very large rotation of the top beam occurred due to inherent unavoidable non-symmetry of the wall, thus resulting in unrealistic kinematic boundary conditions at the top. In addition to that, with such system it was impossible to follow the post-peak branch of the curve, due to loss of control after the formation of the diagonal crack. As a consequence, starting from wall CS02, the tests were carried out with the “kinematic” criterion, i.e. keeping the top beam horizontal.

Figure 16 Wall CS01. Double fixed,  $l=1.25$  m,  $\sigma_v=1.0$  MPa

High ductility values were found for almost all walls including some of those failing in shear. The lower values were reported for wall CS01 and CS04 for which a sudden drop in the strength was due to brittle diagonal shear crack (CS01 was affected also by loss of control once the diagonal crack developed), whereas walls CS02 despite failing with diagonal cracking, displayed a slightly higher ductility and drift capacity. Wall CS03, characterized by progressive damage propagation for opening and closing of the vertical unfilled head joints attained a remarkable ductility and drift. Wall CS05 characterized by the presence of head joints filled by mortar was able to largely exceed 1% drift with a flexure-dominated response before the occurrence of a diagonal shear crack.

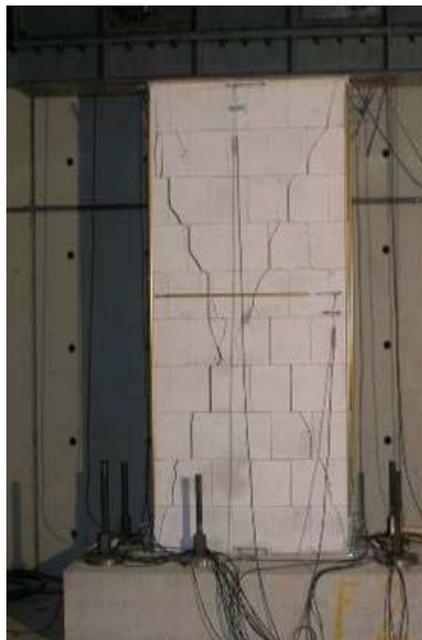
The failure of wall CS02 was characterized by corner-to-corner diagonal shear cracks. The cracks developed in the units and in the mortar bedjoints. The units at the top right and top left corner of the wall rotated producing a concentrated compression load that caused diagonal cracks at the units below. Spalling of the units at the centre of the pier occurred and the development of many wide diagonal cracks in the units at the centre of the panel caused the brittle collapse of the wall, with a sudden drop of the shear force.

Figure 17 Wall CS02. Double fixed,  $l=1.25$  m,  $\sigma_v=1.0$  MPa

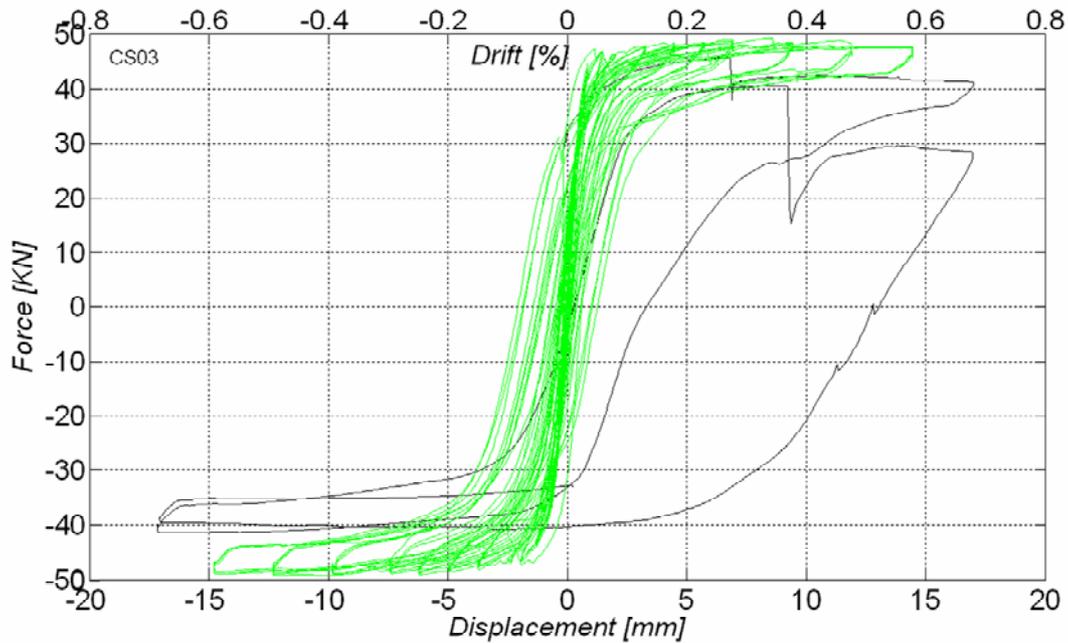
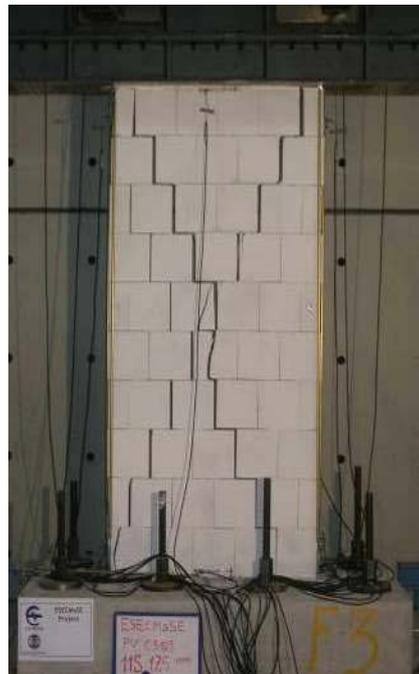
Wall CS03 was characterized by the opening of the unfilled head joints which became evident at the top displacement  $\delta = \pm 10$  mm. The head- and bed-joint cracks formed a pattern of stepped diagonal cracks along the height of the wall. These cracks closed during unloading. Increasing the top displacement the cracks became rather wide and no further increase of shear was possible. When the top displacement exceeded 15 mm, cracks developed in the units at the centre of the panel, producing large strength degradation and collapse of the wall.

Figure 18 Wall CS03. Double fixed,  $l=1.25$  m,  $\sigma_v=0.5$  MPa

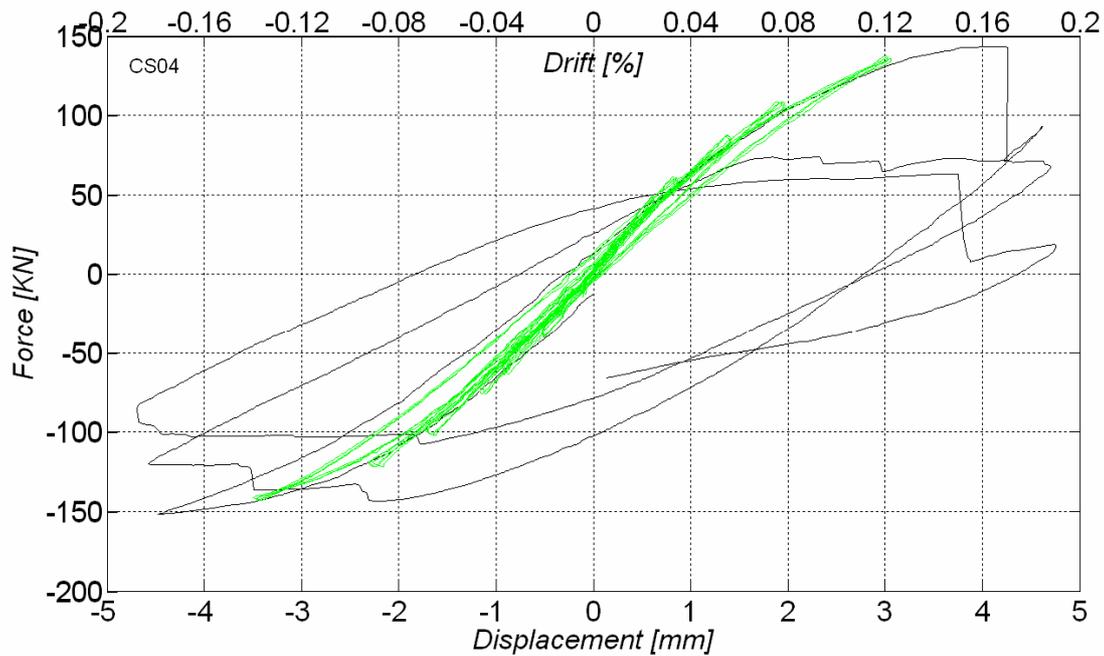
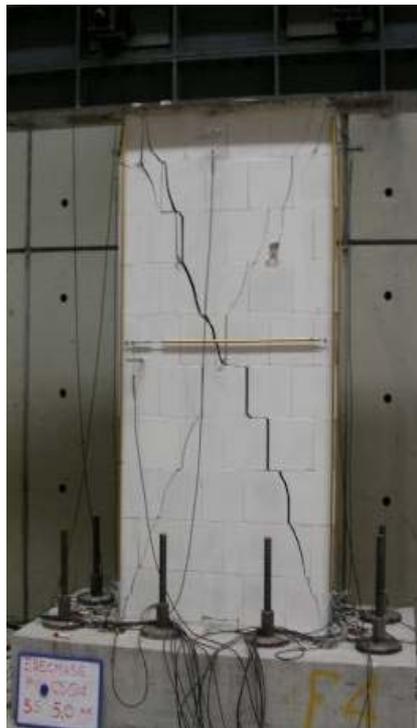
In wall CS04, a higher vertical load ( $\sigma_v=2$  MPa) was applied, and the wall failed with diagonal shear cracks in the masonry units from corner to corner of the wall, at very small top displacement (just beyond 4.0 mm). Spalling of some units at the centre of the wall also occurred. Large strength and stiffness degradation occurred after diagonal cracking. Before attaining this displacement level no evident damage was present, therefore it is possible to state that this wall behaved almost similar to an elastic-brittle system.

Figure 19 Wall CS04. Double fixed,  $l=1.25$  m,  $\sigma_v=2.0$  MPa

In the case of walls failing by shear, the drift capacities were very low, especially in the case of high values of axial load. Wall CS04 attained a value of drift less than 0.14%.

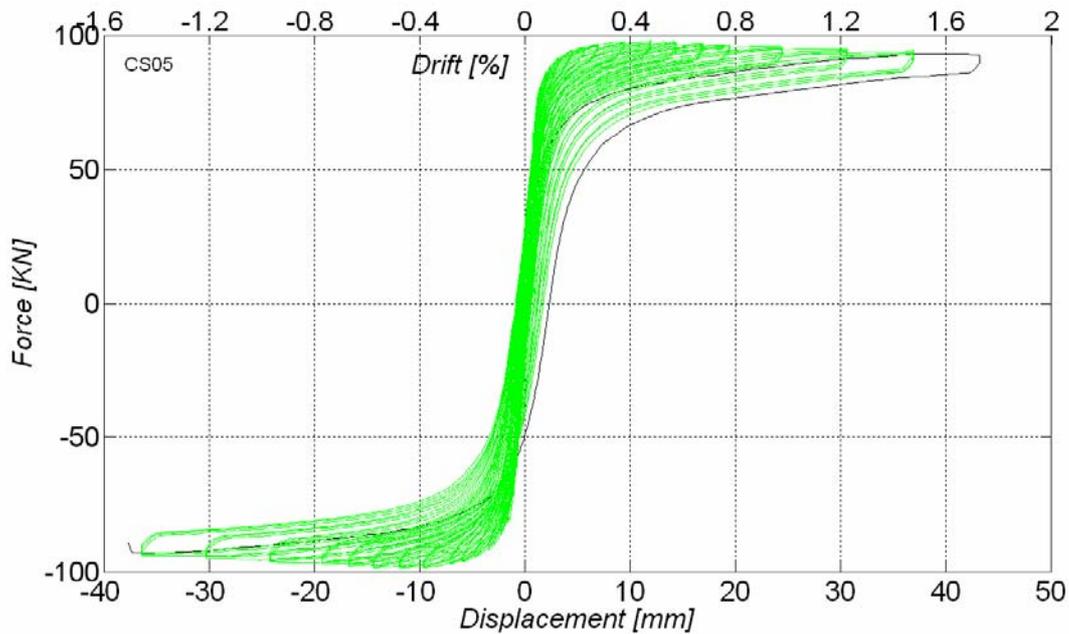
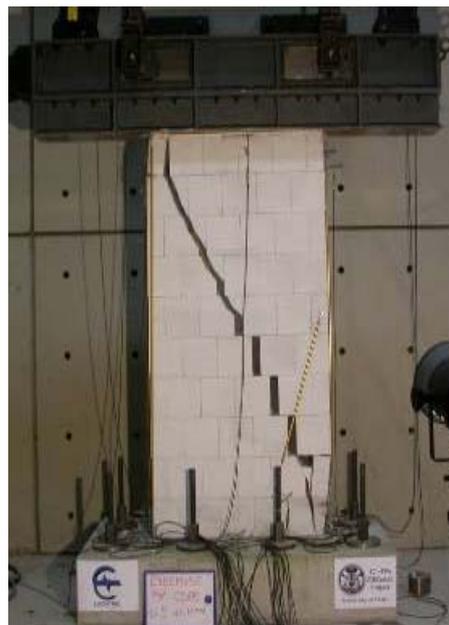
Wall CS05 remained undamaged, with the exception of some tension cracks in bedjoints, up to a horizontal top displacement of 35 mm. When this displacement level was exceeded, the wall failed suddenly in shear with the development of a diagonal crack formed in the mortar bedjoints and in the units. Before this damage, the force-displacement curve presented “S-shaped” cycles with low energy dissipation, similar to a typical rocking behaviour.

Although wall CS05 was constructed and tested with the same characteristics of wall CS01 and wall CS02, head joints filled by mortar allowed to attain a larger displacement capacity in comparison with the displacements found in the tests on wall CS01 and wall CS02.

Figure 20 Wall CS05. Double fixed,  $l=1.25$  m,  $\sigma_v=1.0$  MPa, filled head joints

The failure mechanism of walls CS05, has been classified conventionally as “hybrid” due to the coexistence of a force-displacement response typical of rocking systems, attaining large drifts, which at some point comes to an abrupt failure due to the development of a stepped diagonal crack.

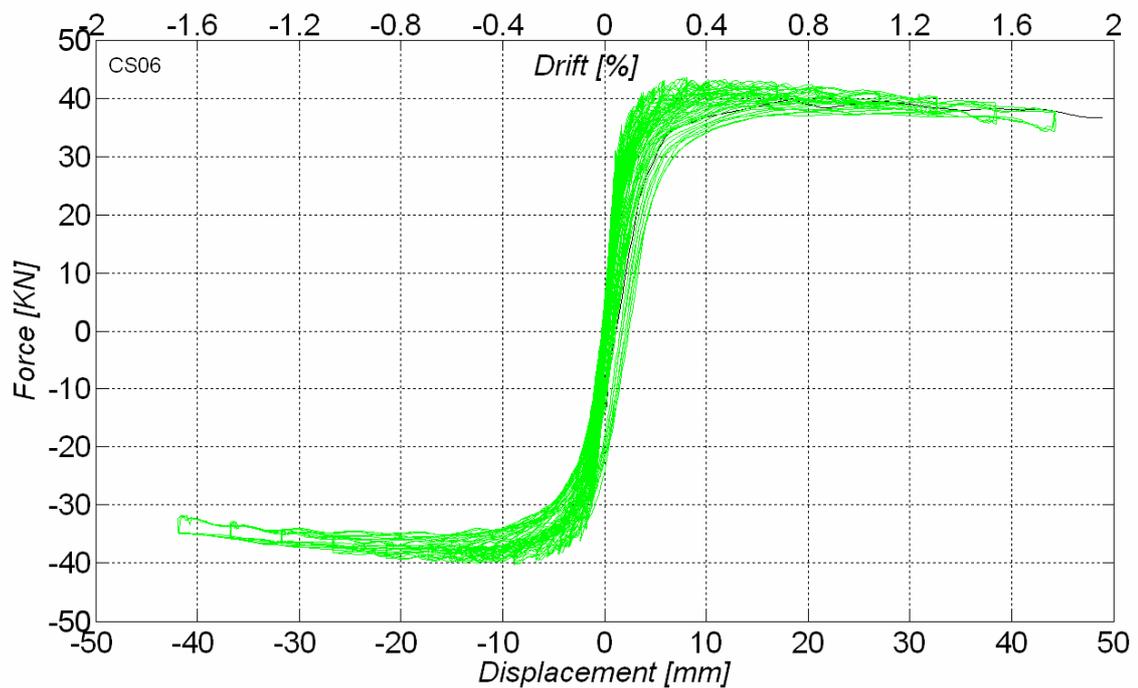
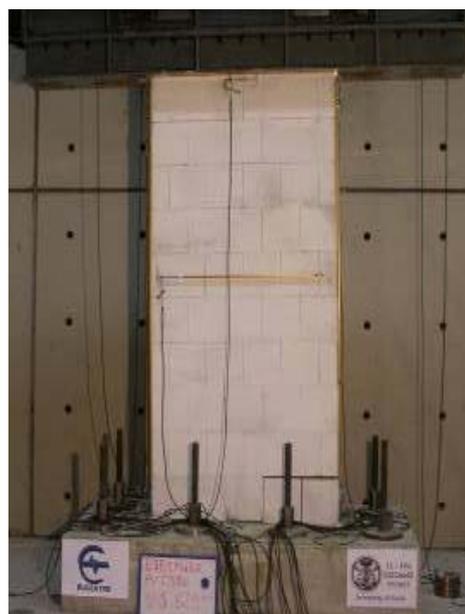
Wall CS06 was tested as a cantilever system. No diagonal cracks occurred during the test and the wall displayed a typical rocking behaviour without any significant strength degradation or relevant energy dissipation. With a top displacement larger than 40 mm (corresponding to a drift of 1.6 %) a wide horizontal crack was clearly visible in the bottom right corner of the panel due to tension stresses. The test was interrupted when the top displacement attained about 50 mm (2% drift) for reasons due to the stroke limits of the transducers; at that stage the wall was substantially undamaged (except for the horizontal crack) and probably it would have been still possible to further increase the displacement demand.

Figure 21 Wall CS06. Cantilever,  $l=1.25$  m,  $\sigma_v=1.0$  MPa

Very high values of ductility and drift capacity were found for walls CS06, CS07 and CS08. The behaviour of wall CS06 is typical of rocking-flexure failure. Walls CS07 and CS08 displayed however the coexistence of a force-displacement response typical of rocking systems with the presence of stepped inclined cracks interesting bed- and headjoints (gaping mechanism) and could be considered a sort of hybrid mechanism. The maximum displacement attained for such walls was more related to the experimental set-up displacement capacity or to the local damage more than significant shear strength degradation. Wall CS08, tested as a cantilever, attained unexpectedly a lower drift and ductility than its double fixed counterpart (CS07), although the drift capacity is quite high compared to the walls failing in shear.

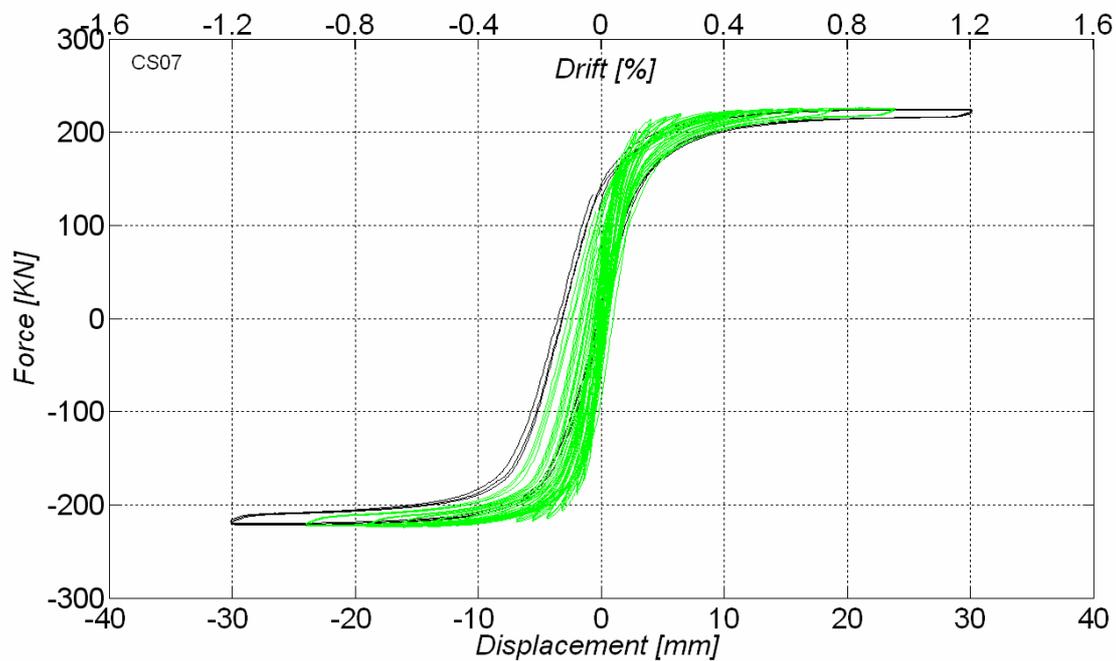
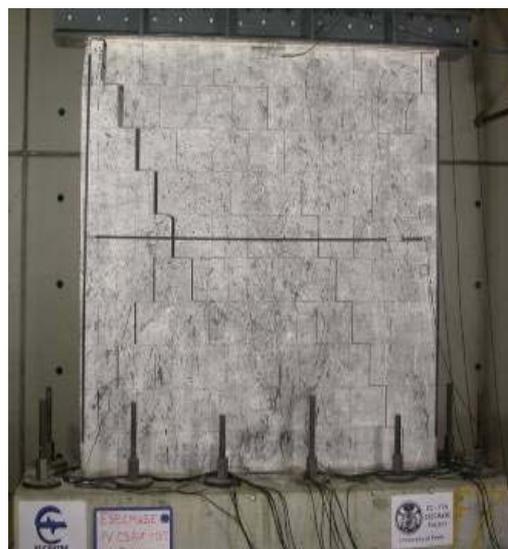
Wall CS07 was characterized by a force-displacement response typical of rocking failure (s-shape, low dissipation), nevertheless at a horizontal displacement of about  $\pm 17$  mm the opening of the unfilled head joints was very evident, indicating that a “gaping” failure mode was governing the response. Cracking of bedjoints concurred to form a system of stepped diagonal cracks along the wall. These cracks closed during unloading. The hysteresis cycles showed very low energy dissipation and no strength degradation since no cracks in the units or sliding in bedjoints occurred. The test was interrupted when the top displacement was 30 mm (1.2% drift) because wide vertical cracks in the joints had developed and separation of a large wedge of masonry took place, with the danger of a partial collapse of the wedge itself.

Figure 22 Wall CS07. Double fixed,  $l=2.50$  m,  $\sigma_v=1.0$  MPa

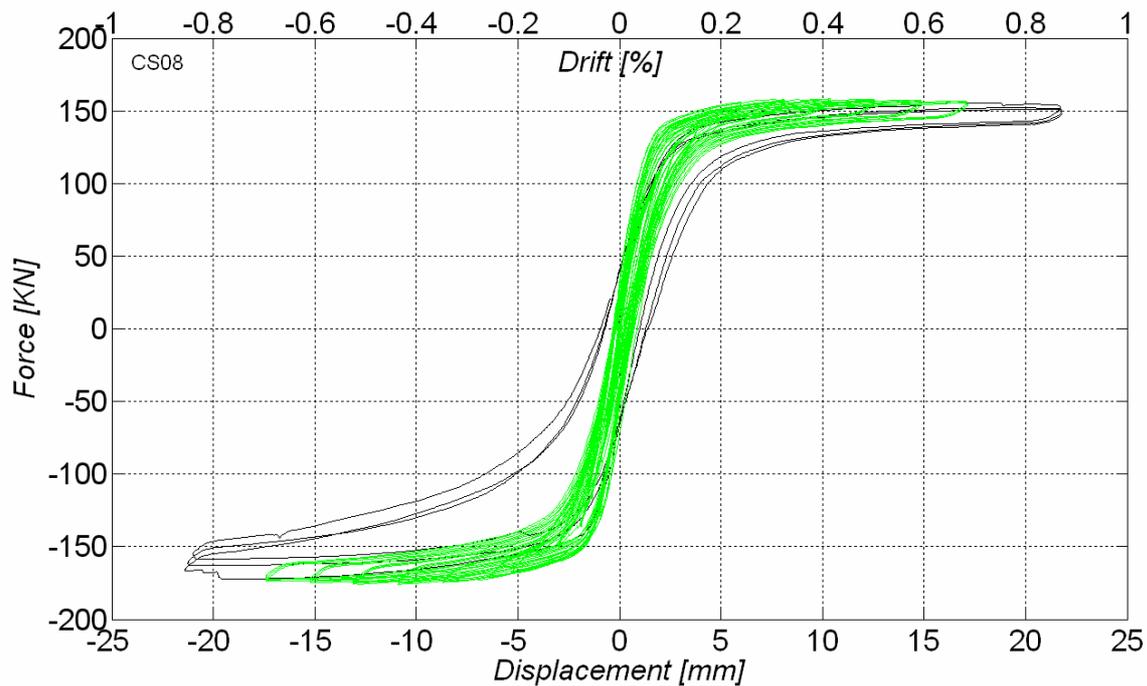
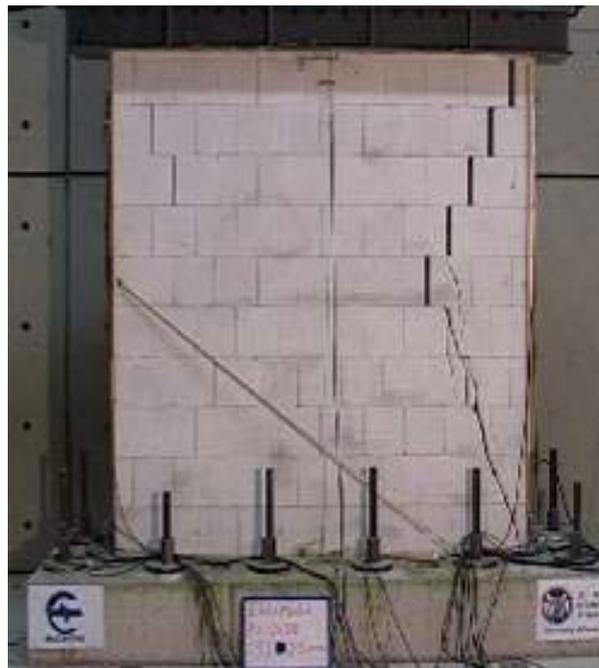
Wall CS08 had same geometric characteristic and same vertical load of wall CS07 but it was tested as a cantilever system. At a horizontal displacement of about  $\pm 12$  mm opening of the unfilled head joints became visible to form stepped inclined cracks along the height of the wall. Low energy dissipation and no strength degradation occurred. Cracks closed during unloading. Rocking/gaping-type response of the wall was displayed. Beyond a top displacement of 20 mm several diagonal cracks in the units of the right bottom half part of the wall developed and in these last cycles a slightly higher energy dissipation was displayed.

Figure 23 Wall CS08. Cantilever,  $l=2.50$  m,  $\sigma_v=1.0$  MPa

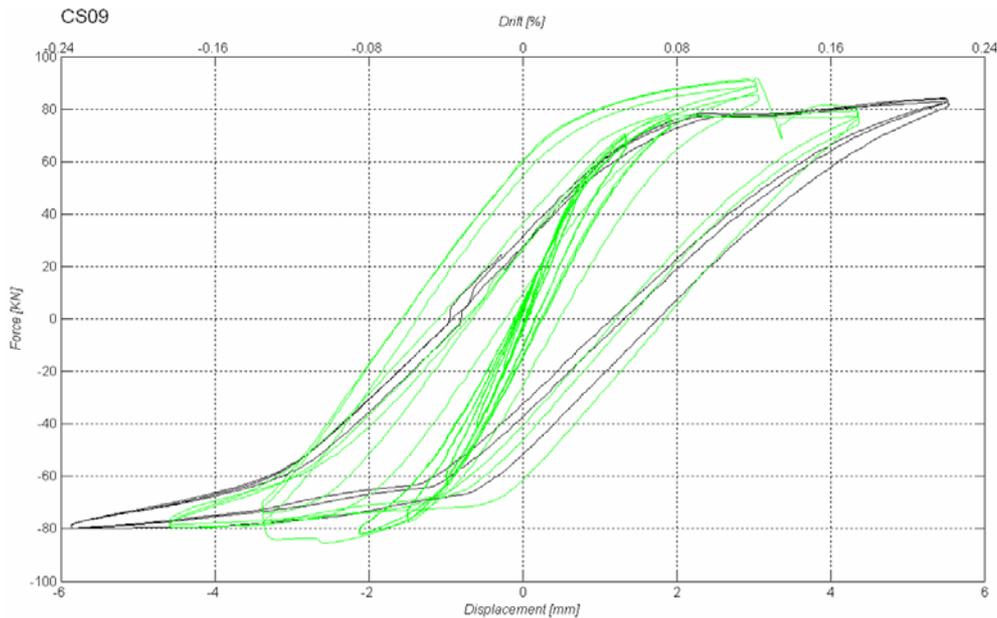
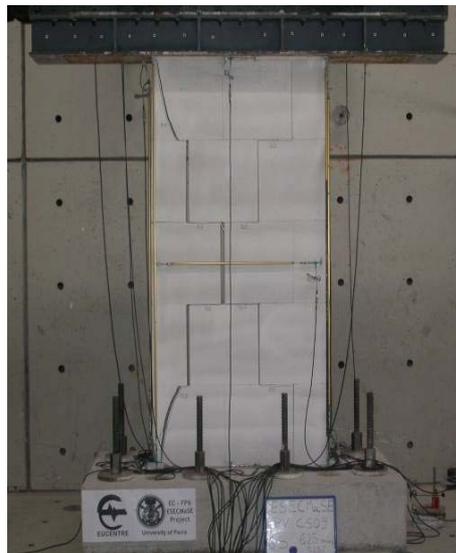
Wall CS09 was the only unreinforced wall constructed with “Quadro E” units. The wall has been subjected to a first visible damage at a drift of about 0.10%. At that stage a diagonal crack in the top left unit occurred from the top corner of the wall. Horizontal sliding at the centre of the panel was shown and a diagonal crack at the bottom left unit also occurred. Strength degradation due to cracks in the units is evident in the force-displacement curve. The head- and bed-joint cracks formed a pattern of stepped diagonal cracks along the height of the wall. These cracks closed during unloading. The test was interrupted when the width of the opening of the unfilled head joints at the centre of the panel became large (at the end of the test reached more than 20 mm).

Figure 24 Wall CS09. Unreinforced, double fixed,  $l=1.25$  m,  $\sigma_v=1.0$  MPa

The unreinforced wall CS09 failed in shear with the occurrence of stepped diagonal cracks along the height of the wall. This wall experienced a minimum ultimate ductility equal to 3.7 and very low drift capacity (0.22%). The elastic stiffness was found very similar to the stiffness computed for the walls constructed with “optimised” units.

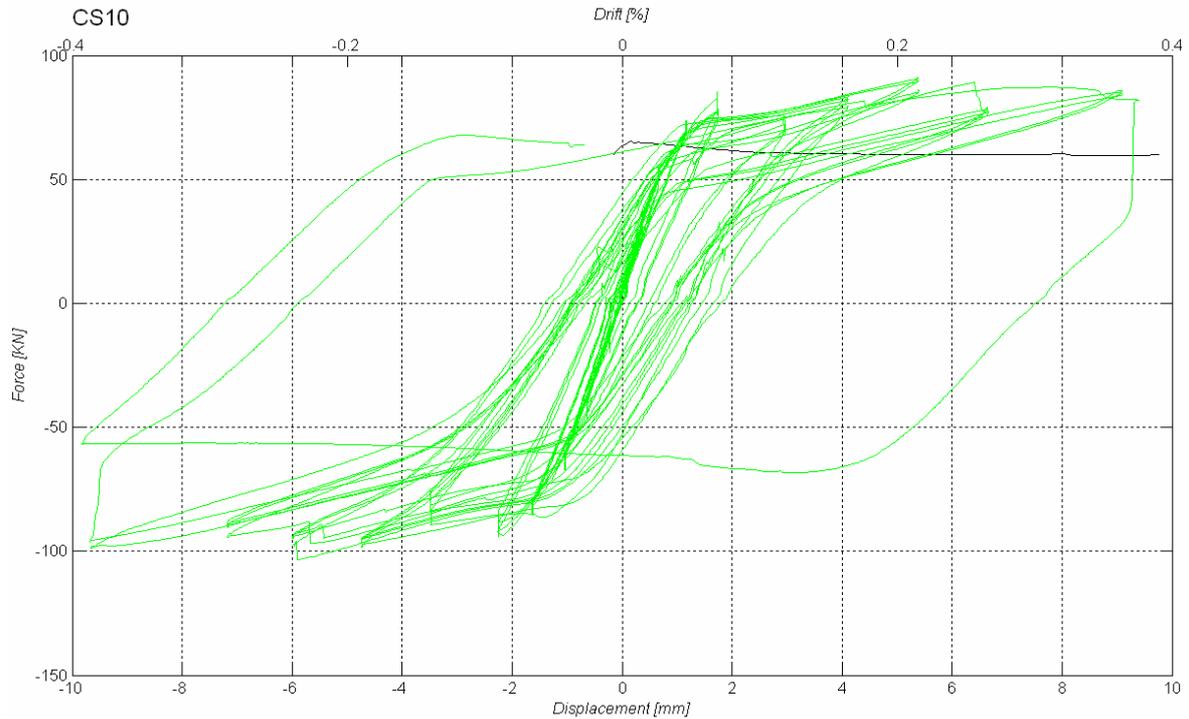
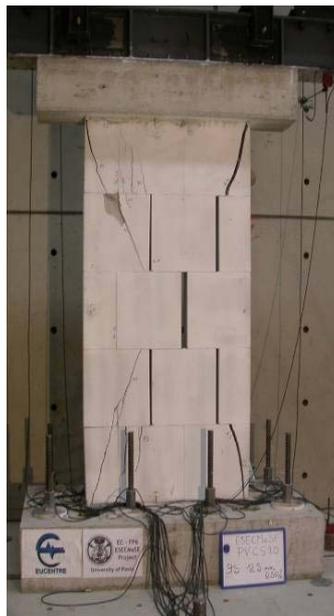
The walls CS10, CS11, CS12 and CS13 were confined with 1  $\phi$  16 at each end of the wall. The opening of the vertical headjoints occurred at low levels of horizontal drift (0.05%) but no stiffness degradation was evident in the F-D hysteresis. In the cycles at a drift of 0.15%, diagonal cracks in the corner units of the right side of the wall appeared. The collapse of the wall happened when cracks in the corner units of the left part of the wall formed (0.4% drift). At this point very wide vertical cracks in the headjoints were also evident.

Figure 25 Wall CS10. Confined (1+1 $\phi$ 16), double fixed,  $l=1.25$  m,  $\sigma_v=1.0$  MPa

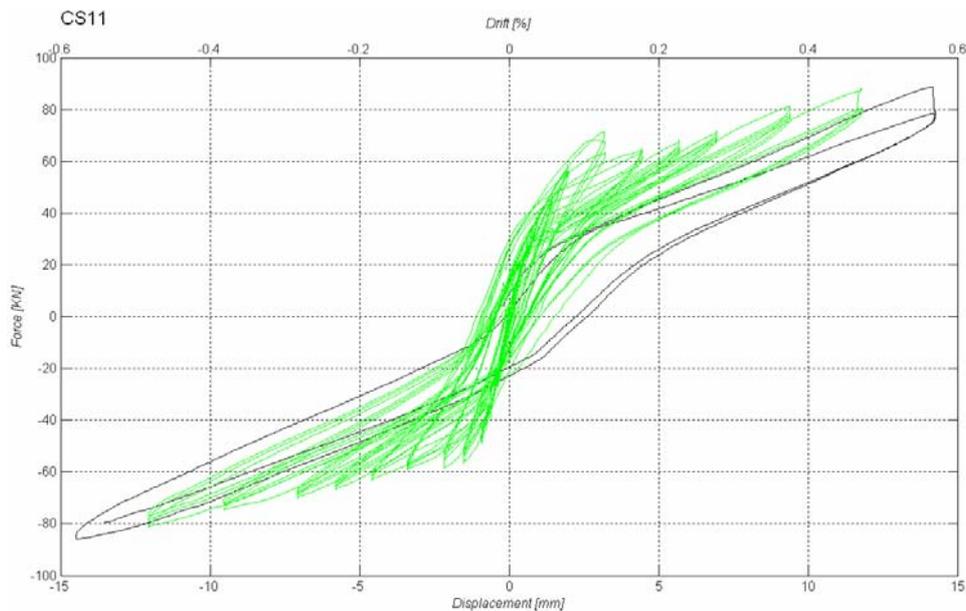
A lower level of vertical stress was applied (0.5 MPa) on wall CS11 with respect to wall CS10. At low levels of horizontal drift (0.10%) small cracks in the units formed. Horizontal and vertical cracks in the joints concurred to form a system of stepped diagonal cracks along the wall; these cracks closed during unloading without any loss of strength or stiffness. In the cycles at a drift of 0.15%, the opening of two large diagonal cracks in the corner units of the left side of the wall appeared. In the following cycle the diagonal crack in the lower unit propagated up to the base of the unit. The wall presented an uncracked behaviour up to the occurrence of these latter diagonal cracks in the calcium silicate units. The collapse of the wall was reached when a wide diagonal crack in the bottom corner unit of the right part of the wall formed (0.6% drift). A slightly higher displacement capacity was reached in comparison with wall CS10.

Figure 26 Wall CS11. Confined (1+1 $\phi$ 16), double fixed, l=1.25 m,  $\sigma_v=0.5$  MPa

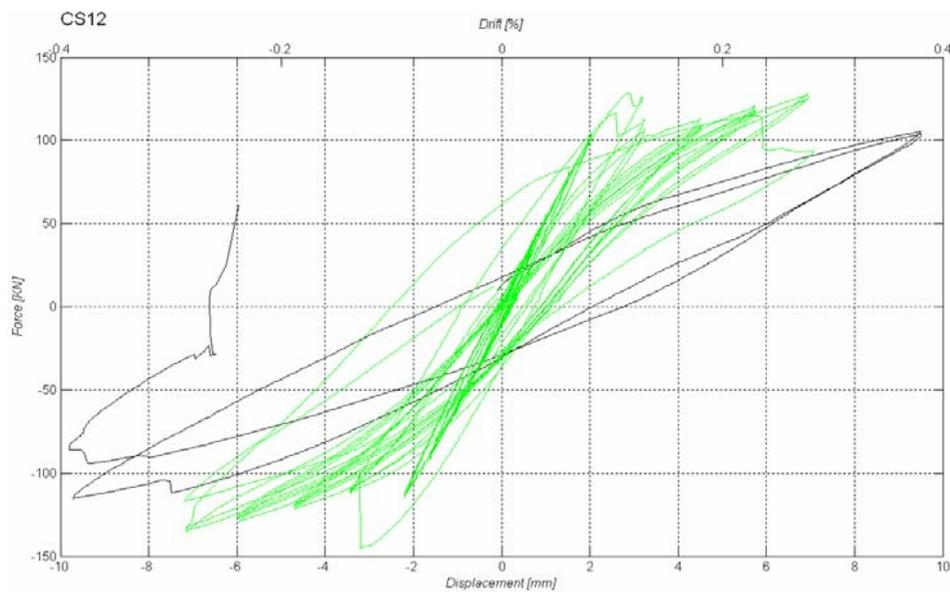
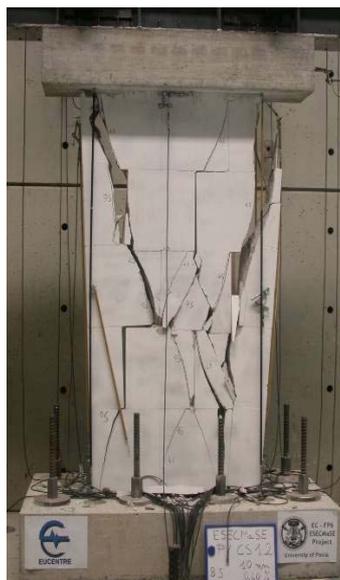
A large vertical stress (2 MPa) was applied on wall CS12. The wall remained substantially uncracked up to a top displacement of about 3 mm when several small diagonal cracks in the units formed, after which strength degradation was shown. In the following cycles these cracks propagated and diffused throughout the pier. In the cycle correspondent to a drift of 0.3 % a large diagonal crack in the center of the panel appeared and, as a consequence, strength degradation happened. Spalling of some units in the center of the wall also occurred. The collapse of the wall was reached when the horizontal displacement was slightly less of 10 mm, the diagonal cracks in the wall became very wide and the wall lost any capacity of resisting the horizontal forces.

Figure 27 Wall CS12. Confined (1+1 $\phi$ 16), double fixed, l=1.25 m,  $\sigma_v=2.0$  MPa

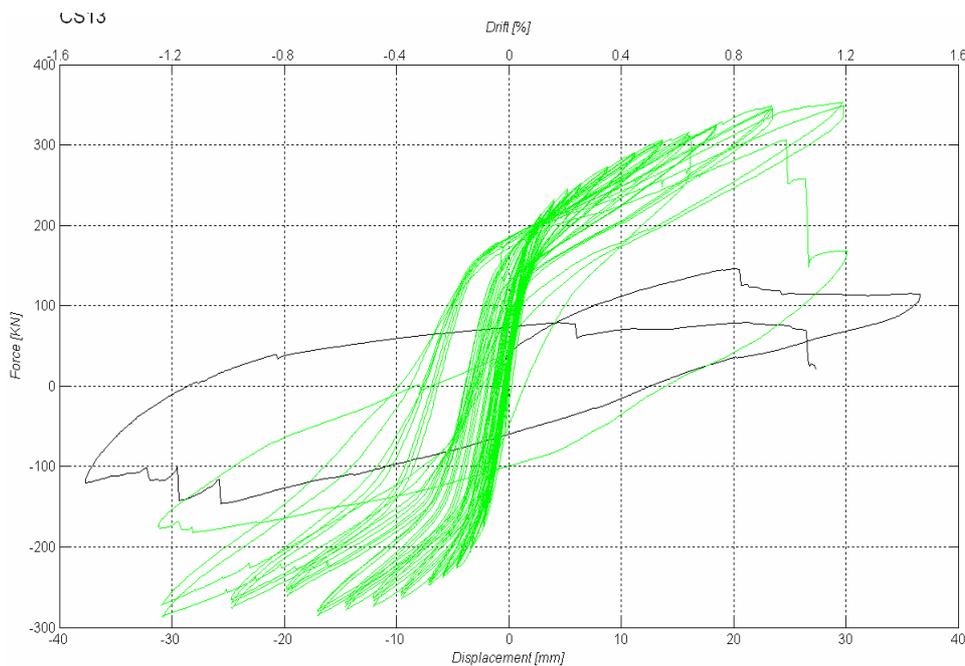
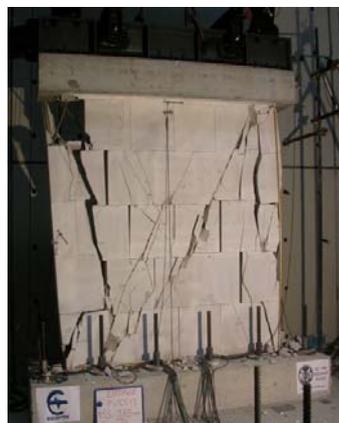
The confined wall CS13 was 2.5 m long with a vertical stress of 1 MPa. The wall remained undamaged up to a top displacement of about 3 mm. Horizontal and vertical cracks in the joints concurred to form a system of stepped diagonal cracks along the wall; these cracks closed during unloading without any loss of strength or stiffness. In the cycles at a drift of 0.6%, the opening of a diagonal crack in the unit at the center of the wall appeared. In the following cycle several diagonal cracks formed in the units propagated down to the base of the wall. Both the stepped diagonal cracks and the cracks in the units became very wide and separation of large masonry wedges at both sides of the wall took place at a drift of 1.2%. The spalling of the masonry units and the separation of the masonry wedges exposed the steel rebars. At this level of horizontal displacement a significant loss of strength occurred and the wall collapsed. In this test a very large value of shear strength was reached.

Figure 28 Wall CS13. Confined (1+1 $\phi$ 16), double fixed,  $l=2.50$  m,  $\sigma_v=1.0$  MPa

Values of ductility higher than the majority of the other confined walls was estimated for wall CS13. The damage pattern occurred to the wall appeared to be a typical shear failure mechanism even if a rather high value of displacement capacity was found (ultimate drift =1.21 %) before a significant loss of strength. The elastic stiffness of the confined wall CS13 is quite similar to the elastic stiffness of the unreinforced wall CS08.

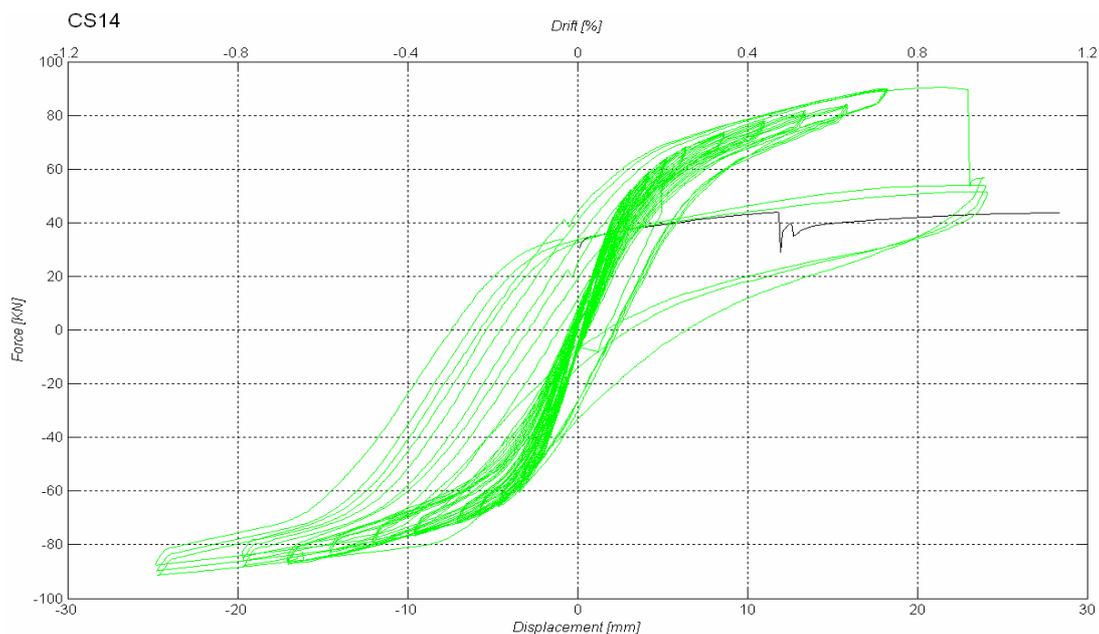
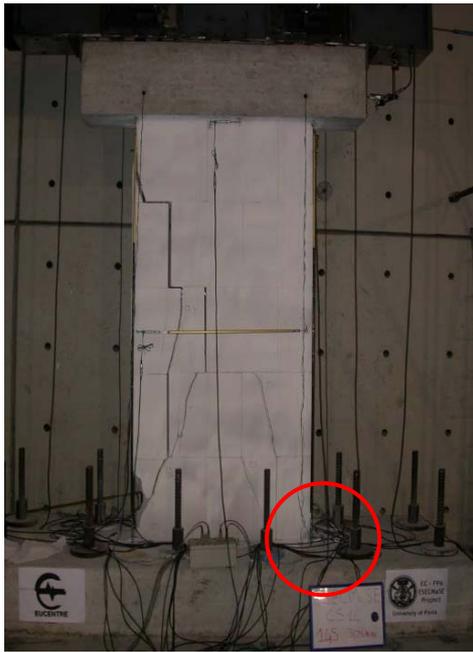
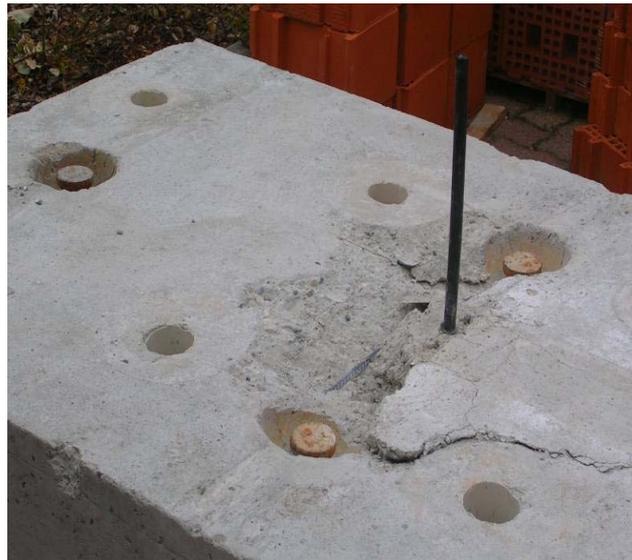
No appreciable damage was evident up to drift equal to 0.4-0.5% and the shape of the hysteresis curve was similar to that of a rocking response. After this level of displacement small diagonal cracks occurred in the units and the hysteresis curve became slightly fatter without, however, reduction in the strength. At a horizontal displacement of about 24 mm (slightly less than 1 % drift), large strength degradation occurred for the failure of the anchorage in the r.c. foundation of the tendon of the right side. The r.c. foundation was cast with concrete having a compressive strength on cube of 30 MPa (C25/30 according to EN 206).

In Figure 29 it is possible to see the damage in the wall and in the foundation.

Figure 29 Wall CS14. Post-tensioned, cantilever,  $l=1.25$  m,  $\sigma_v=1.0$  (+1.0) MPa

A high value of displacement capacity (drift equal to about 1%) was found for wall CS14 (post-tensioned wall). Large strength degradation occurred for the failure of the anchorage in the r.c. foundation of the tendon on the right side. If no failure in the anchorage had occurred, the ultimate ductility and the ultimate displacement would probably have been higher.
