**ESECMaSE**

**Enhanced Safety and Efficient Construction of Masonry Structures in Europe**

**D 7.1c Test results on the behaviour of masonry  
under static cyclic in plane lateral loads**

University of Pavia  
Department of Structural Mechanics  
Via Ferrata, 1  
27100 Pavia, Italy

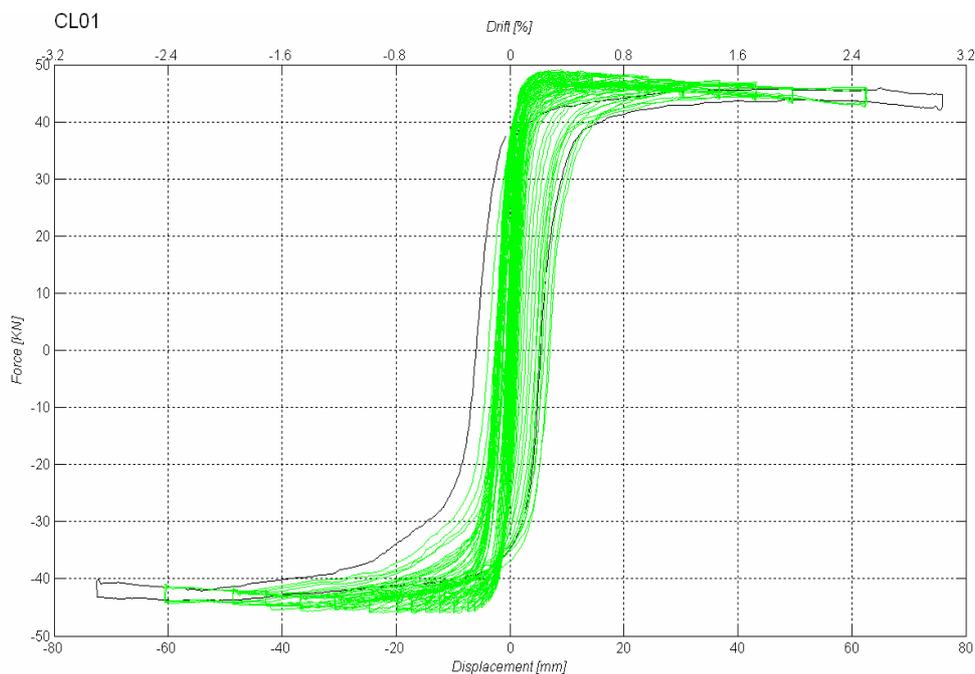
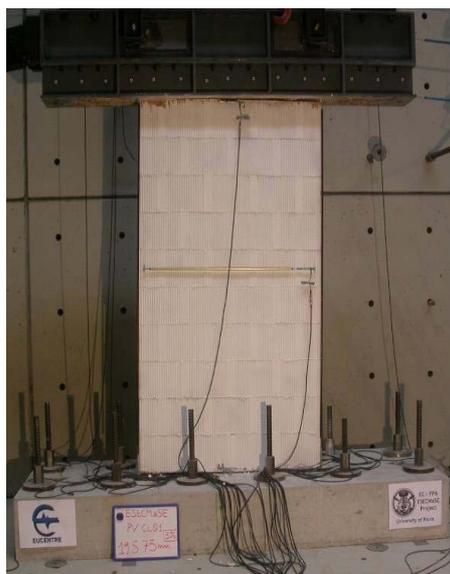
The unreinforced wall CL01 was tested as a double fixed system. No diagonal cracks occurred during the test and the wall displayed a typical rocking behaviour without any significant strength degradation or relevant energy dissipation. With a top displacement larger than 50 mm (corresponding to a drift of 2.0 %) a wide horizontal crack was clearly visible in the top and bottom corners of the panels due to tension stresses. The test was interrupted when the top displacement attained about 70 mm due to the stroke limits of the transducers; at that stage the wall was substantially undamaged (except for the horizontal crack).

Figure 30 Wall CL01. Unreinforced, double fixed,  $l=1.50$  m,  $\sigma_v=0.31$  MPa

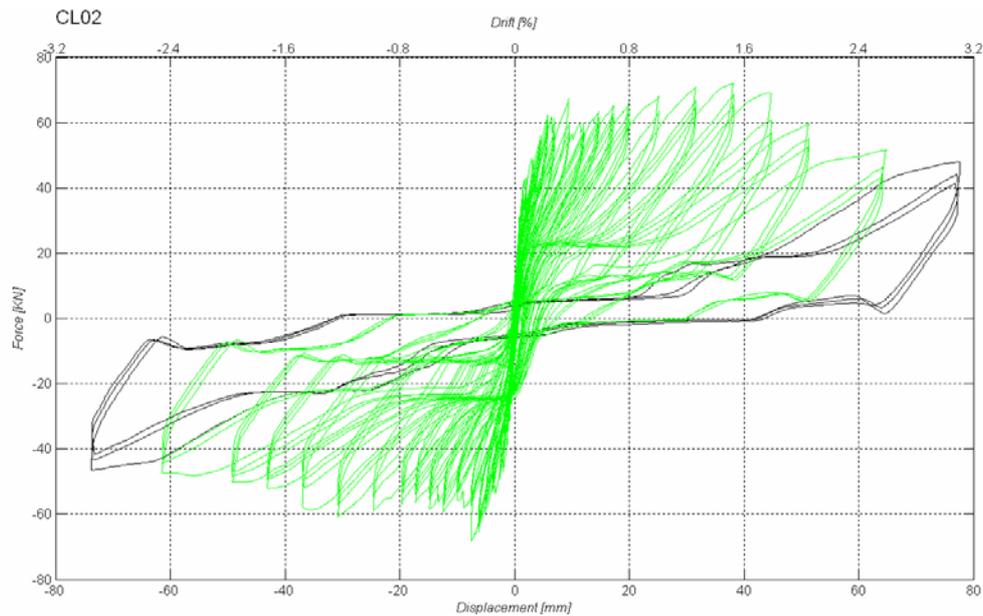
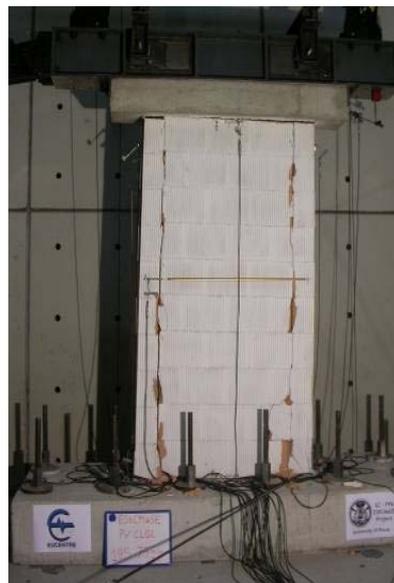
The wall CL02 was confined with 1  $\phi$  16 bar at each end. The wall was tested as cantilever system. This wall has some similarity with a concrete wall with concentrated vertical bars at the ends since the large holes of the clay units were completely filled by concrete. No diagonal cracks occurred during the test. Energy dissipation was due to the yielding of the rebars. At a top displacement larger than 10 mm two vertical parallel cracks at the edges of the walls close to the position of the bars occurred, isolating two r.c. columns at the ends of the walls. Strength degradation after the attainment of peak strength was accompanied also by damage at the compressed corner. The test was interrupted when the top displacement attained more than 70 mm for reasons due to the stroke limits of the transducers and also for quite appreciable strength degradation.

Figure 31 Wall CL02. Confined (1+1 $\phi$ 16), cantilever,  $l=1.50$  m,  $\sigma_v=0.33$  MPa

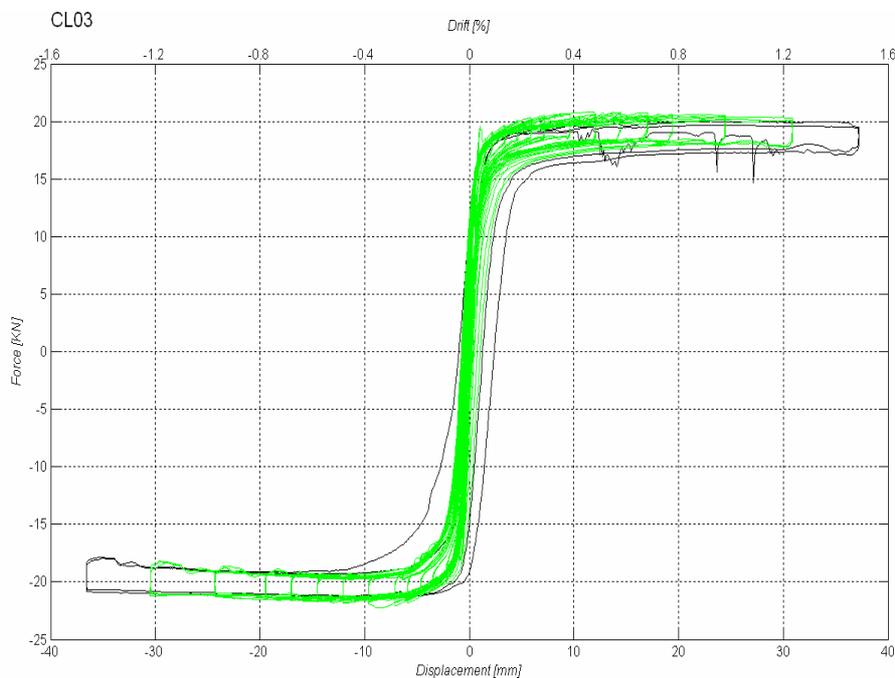
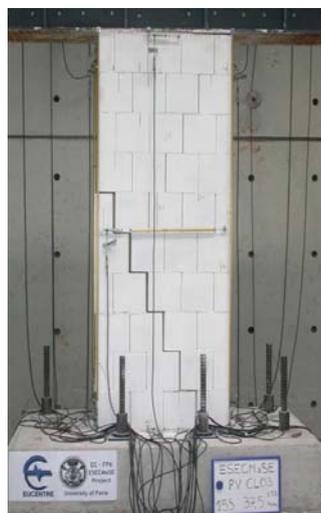
The unreinforced masonry wall CL03 was tested with double fixed boundary condition. The level of the vertical stress was very low (0.14 MPa). No diagonal cracks in the units occurred during the test and the wall displayed a rocking behaviour without any significant strength degradation or relevant energy dissipation. With a drift larger than 1.0 %, horizontal and vertical cracks in the joints concurred to form a system of stepped diagonal cracks along the wall; these cracks closed during unloading without any loss of strength or stiffness. Moreover, wide horizontal cracks were clearly visible in the top corners of the panel due to tension stresses. At the bottom of the wall the horizontal crack due to tension stresses formed at the bedjoints between the first and the second course of the masonry units. The test was interrupted when the top displacement attained about 37 mm for the large damage in the wall.

Figure 32 Wall CL03. Unreinforced, double fixed,  $l=1.00$  m,  $\sigma_v=0.14$  MPa

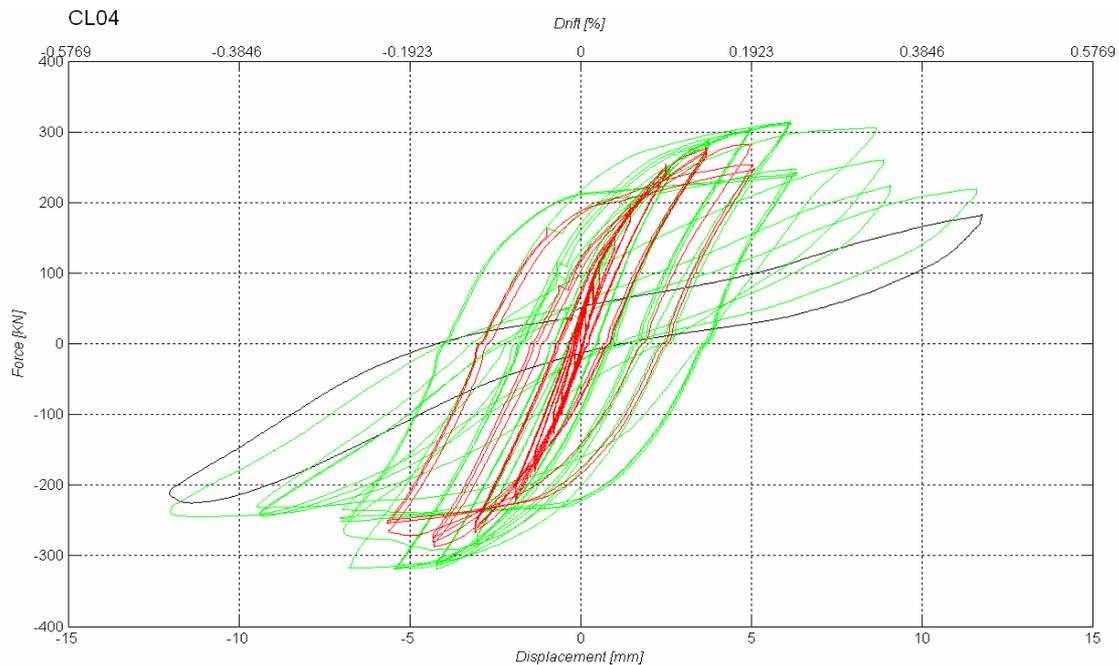
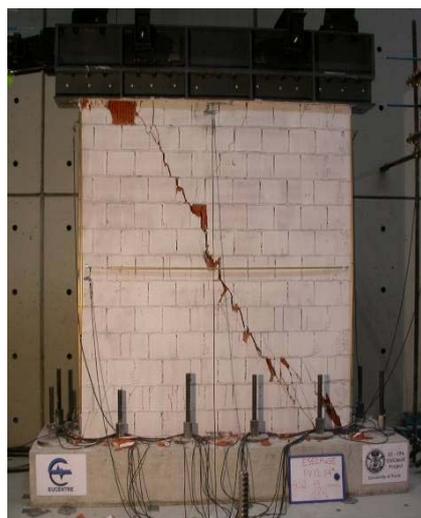
The vertical stress applied on the wall CL04 was initially equal to 0.50 MPa. Nevertheless, significant sliding along the joint between the steel beam at the top and the wall itself was shown after 7 cycles. It was then decided to increment the vertical stress up to 0.68 MPa. At this higher level of compression the wall developed a diagonal cracking failure. Still, the displacement measured at the top beam was found to have a significant component due to sliding. For this reason the hysteresis loops show a large dissipation that was not only associated to cracking in the panel but to a large extent by sliding.

Figure 33 Wall CL04. Traditional unit, G.P. bedjoints and headjoints  $l=2.50$  m. The cycles with  $\sigma_v=0.50$  MPa are shown in red, whereas the cycles with  $\sigma_v=0.68$  MPa are shown in green.

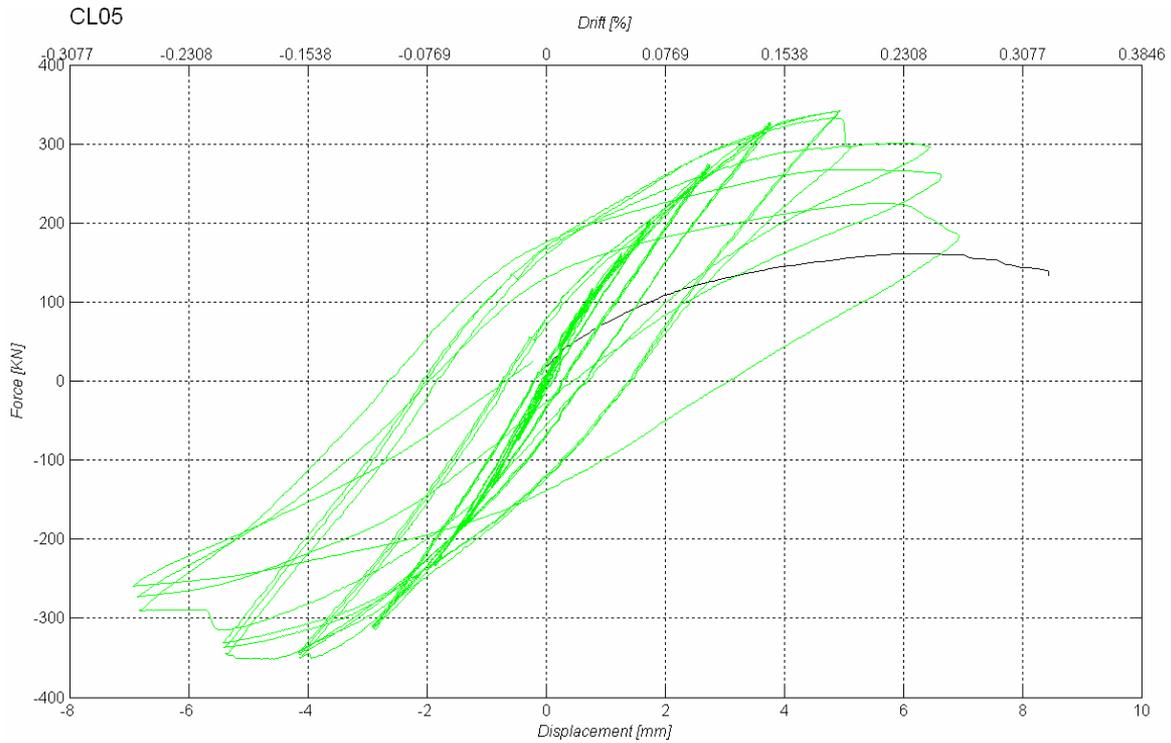
Wall CL06 failed with diagonal shear cracks in the masonry units from corner to corner of the wall, at rather small top displacement (just beyond 0.25% drift). Spalling of some units also occurred. Large strength and stiffness degradation occurred after diagonal cracking. Before attaining this displacement level no evident damage was present except for small diagonal cracks in the units.

Figure 34 Wall CL05. Traditional unit, G.P. bedjoints and headjoints  $l=2.50$  m,  $\sigma_v=0.68$  MPa

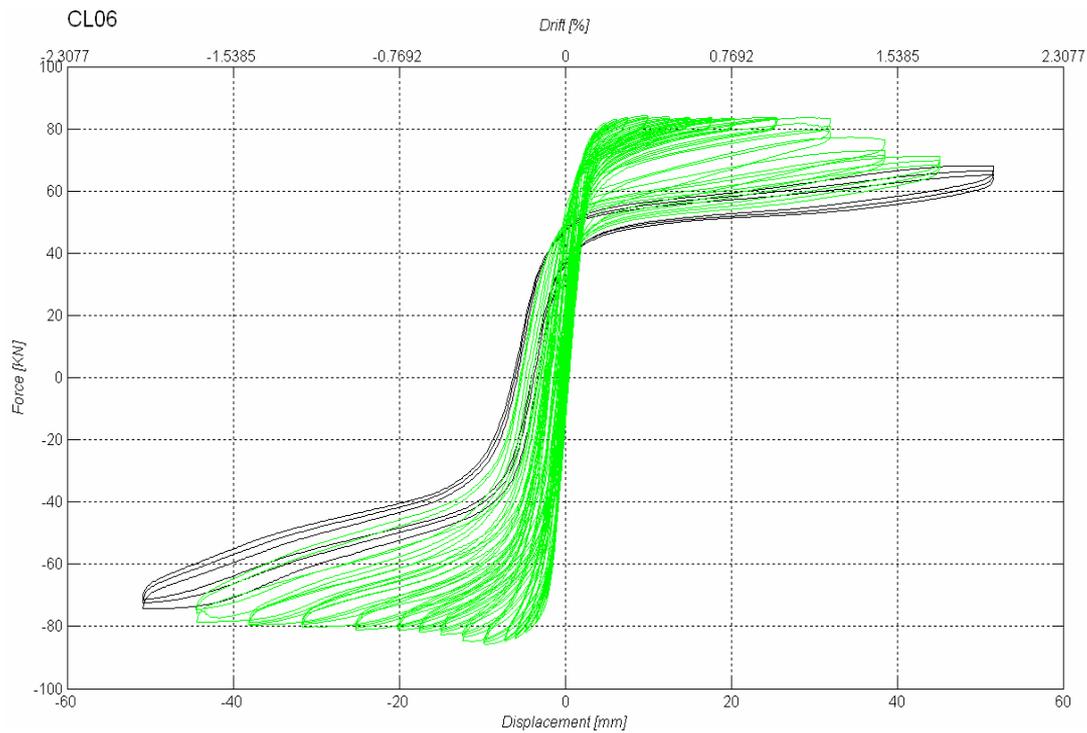
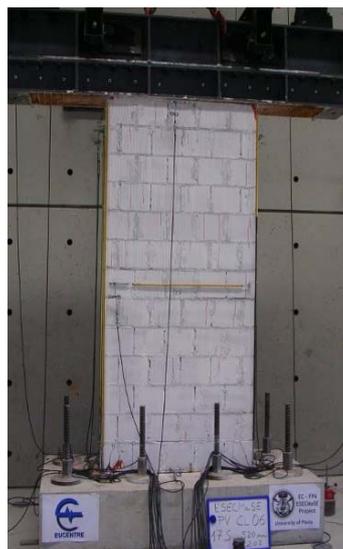
In the wall CL06 no diagonal cracks occurred during the test and the wall displayed a typical rocking behaviour with low energy dissipation. Strength degradation after the peak occurred since the resultant of the compression moved towards the centre of the panel for the concentration of the damage in the compressed corners. A wide horizontal crack was clearly visible in the top corners of the panel due to tension stresses. The test was interrupted when the top displacement attained about 50 mm (slightly less than 2% drift) after a conspicuous strength degradation although displacement capacity reserves were probably still present..

Figure 35 Wall CL06. Traditional unit, G.P. bedjoints and headjoints  $l=1.25$  m,  $\sigma_v=0.50$  MPa

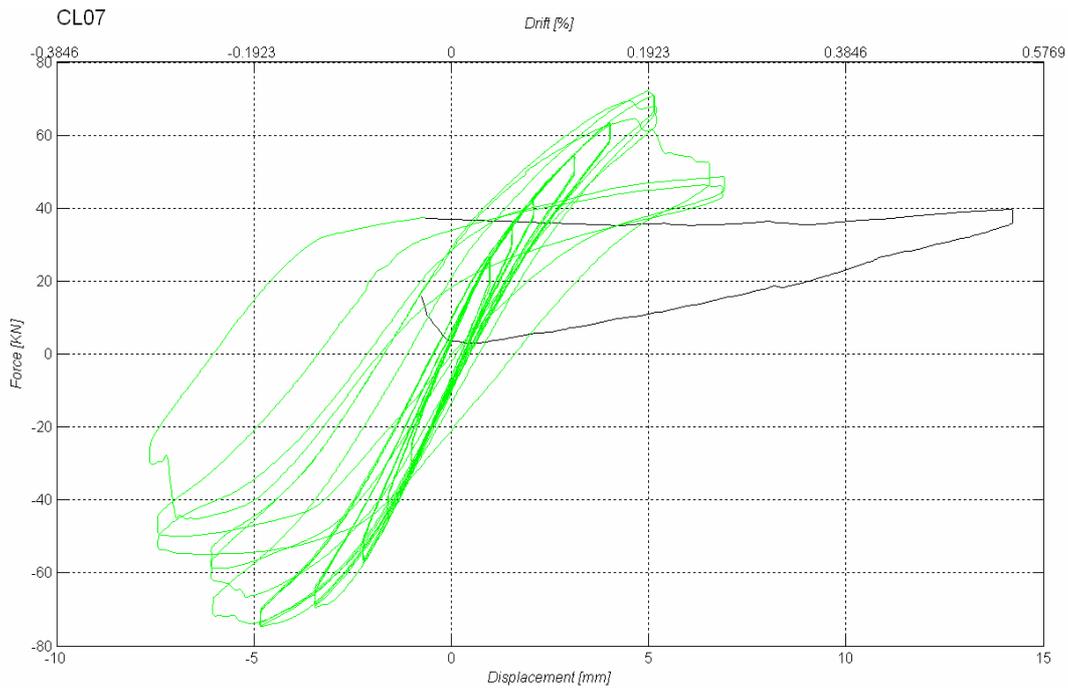
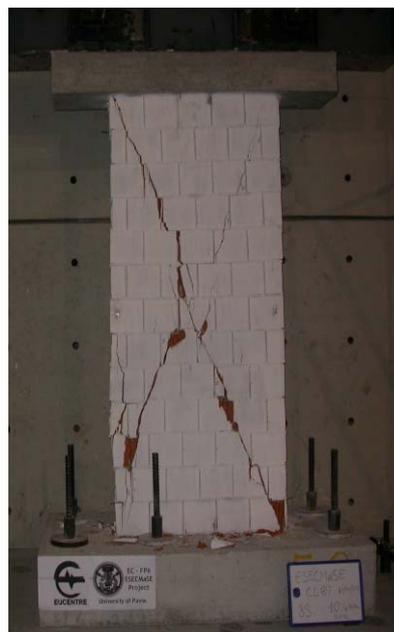
Wall CL07 was constructed with T+G clay units and general purpose mortar. The wall failed with two diagonal shear cracks in the masonry units from corner to corner of the wall, at a rather small top displacement (just below 0.2% drift). Spalling of some units at the centre of the panel also occurred. Large strength and stiffness degradation occurred after diagonal cracking. Before attaining this displacement level no evident damage was present, therefore this wall displayed a rather brittle behaviour.

Figure 36 Wall CL07. T+G unit, G.P. bedjoints, unfilled headjoints  $l=1.25$  m,  $\sigma_v=0.50$  MPa

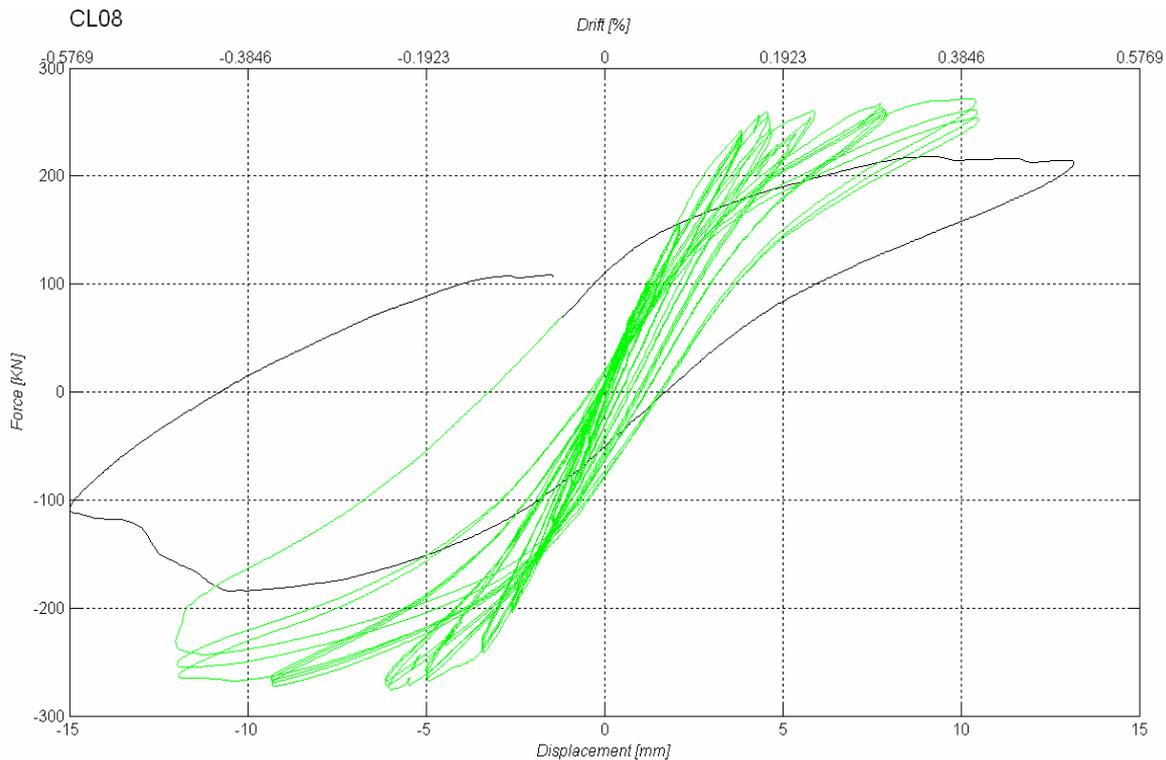
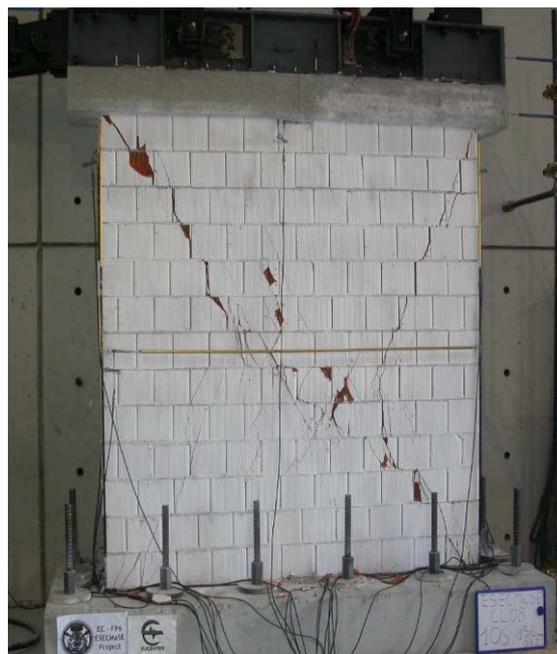
Wall CL08 was of the same typology of wall CL07 but with a length of 2.5 m. The wall failed by shear cracking with the occurrence of two diagonal cracks in the masonry units from corner to corner of the wall. This damage started to appear at a drift of 0.2-0.25% and the cracks developed in the panel up to a drift of 0.4 % when strength degradation occurred. Spalling of some units at the centre of the panel also was evident. The test was stopped for diffused damage and large strength degradation.

Figure 37 Wall CL08. T+G unit, G.P. bedjoints, unfilled headjoints  $l=2.50$  m,  $\sigma_v=0.68$  MPa

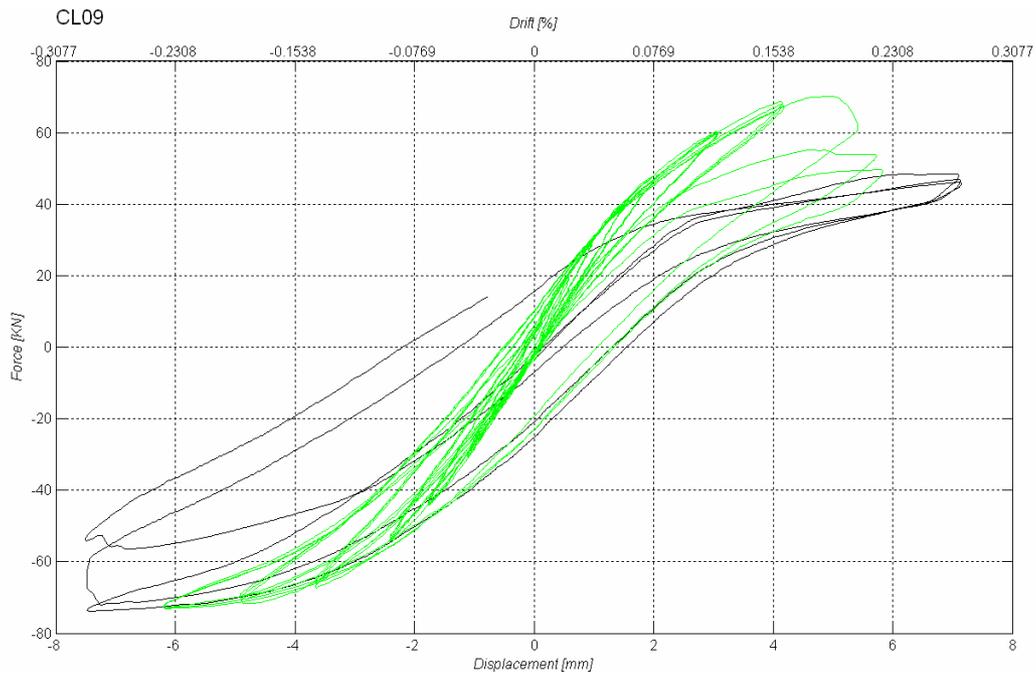
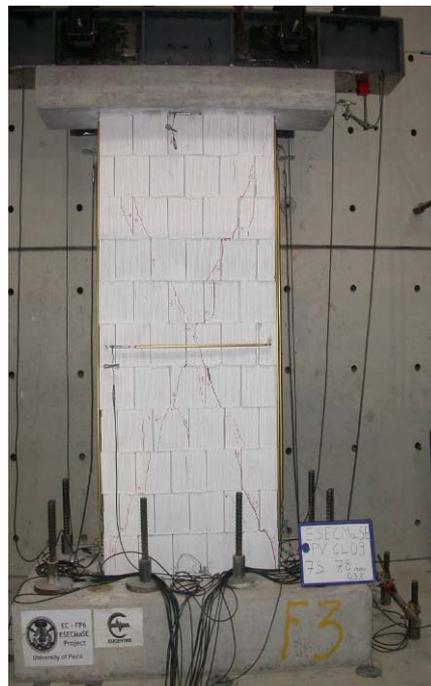
Wall CL09 had the same characteristics of wall CL07 but the bedjoints were made up with thin layer mortar instead of general purpose mortar. The failure mode of this wall was very similar to failure of wall CL07 both for the cracking pattern and for the maximum displacement capacity. The wall failed with two diagonal shear cracks in the masonry units from corner to corner of the wall, at rather small top displacement (below 0.25% drift). Strength degradation occurred after diagonal cracking.

Figure 38 Wall CL09. T+G unit, Thin layer bedjoints, unfilled headjoints  $l=1.25$  m,  $\sigma_v=0.50$  MPa

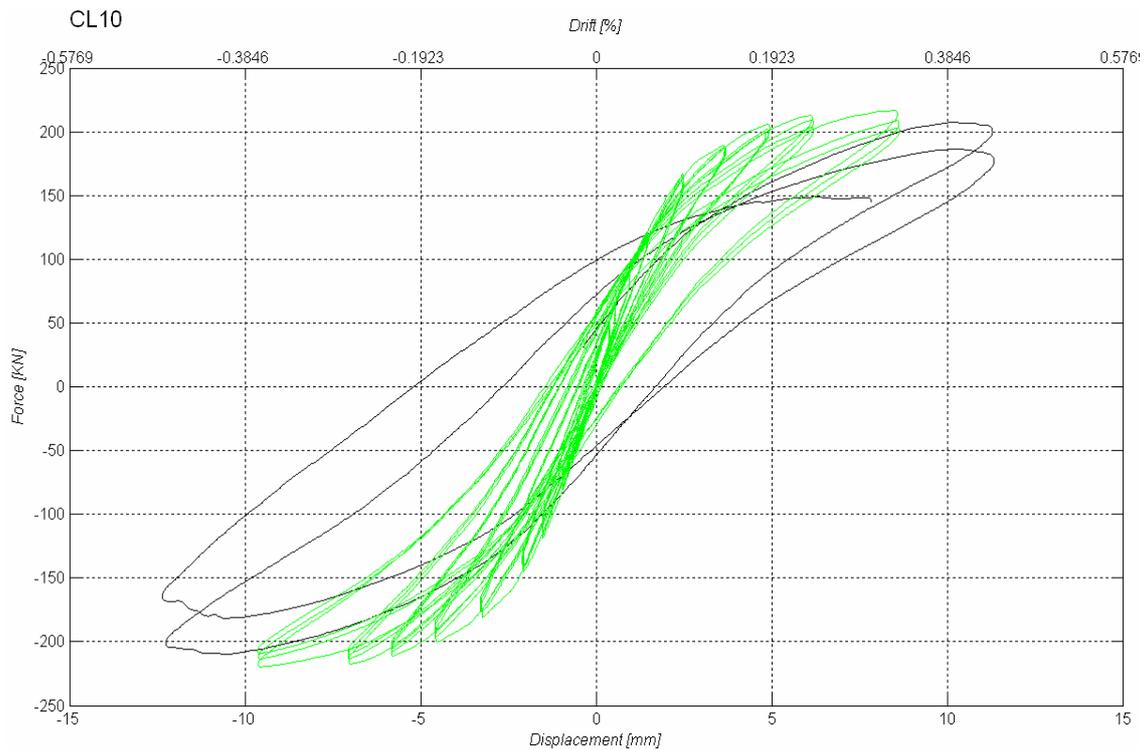
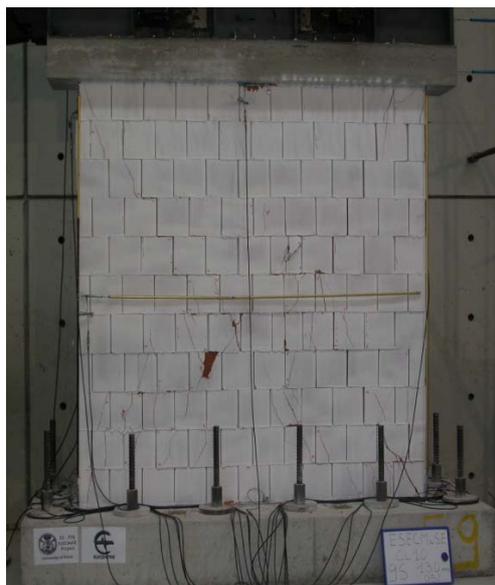
Wall CL10 and wall CL08 showed similar failure modes since the two specimens had the same characteristics in terms of dimensions, vertical load applied and boundary condition. The only difference as respect to wall CL08 were the thin layer bedjoints. Diagonal cracks in the units started to be visible at a drift of about 0.20 %. The wall failed with two diagonal shear cracks in the masonry units from corner to corner of the wall, at small top displacement corresponding to about 0.45% drift. The wall collapsed when strength degradation occurred after the corner to corner diagonal cracking.

Figure 39 Wall CL10. T+G unit, Thin layer bedjoints, unfilled headjoints  $l=2.50$  m,  $\sigma_v=0.68$  MPa

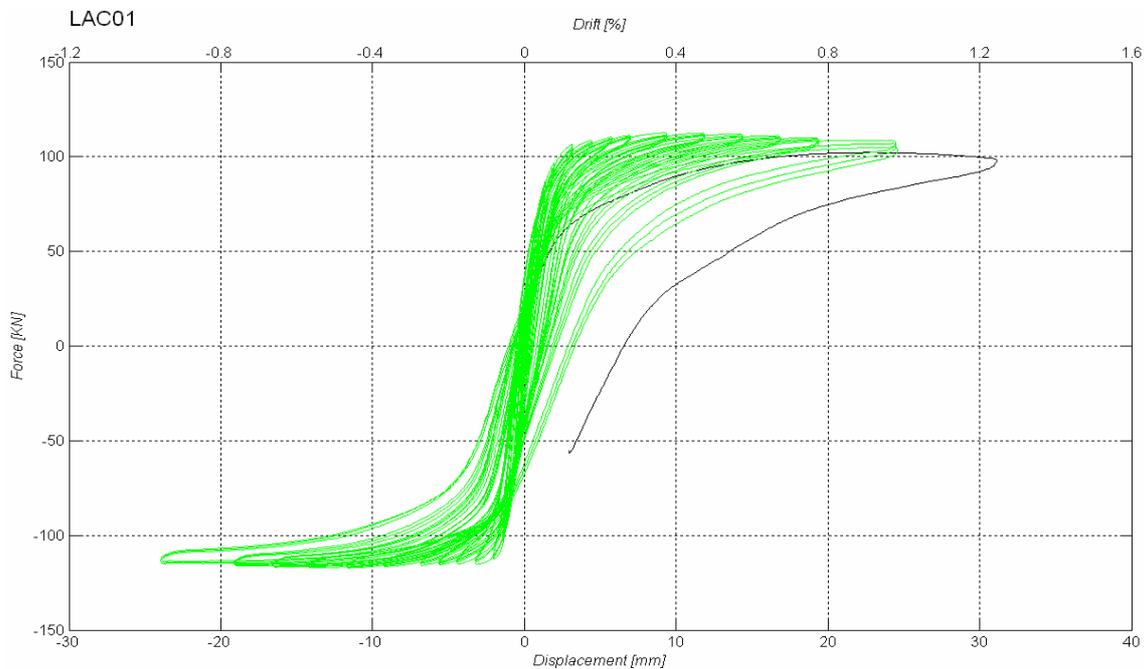
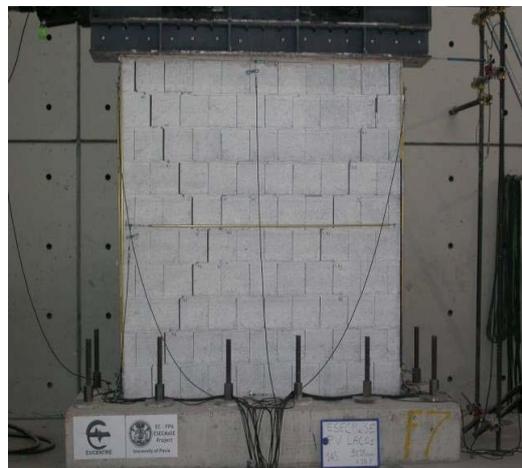
Wall LAC01 was characterized by a force-displacement response typical of rocking/gaping failure. At a horizontal displacement of about  $\pm 12.5$  mm the opening of the unfilled head joints was very evident. Cracking of bedjoints concurred to form a system of stepped diagonal cracks along the wall. These cracks closed during unloading. The hysteresis cycles showed very low energy dissipation without an appreciable strength degradation since no cracks in the units or sliding in bedjoints occurred up to 1% drift when a large horizontal crack at joint under the top steel beam occurred and energy dissipation was developed. The test was interrupted at a drift of 1.25% since large damage occurred in particular because a separation of a masonry wedge was close to happen.

Figure 40 Wall LAC01. G.P. bedjoints, unfilled headjoints,  $l=2.50$  m,  $\sigma_v=0.50$  MPa

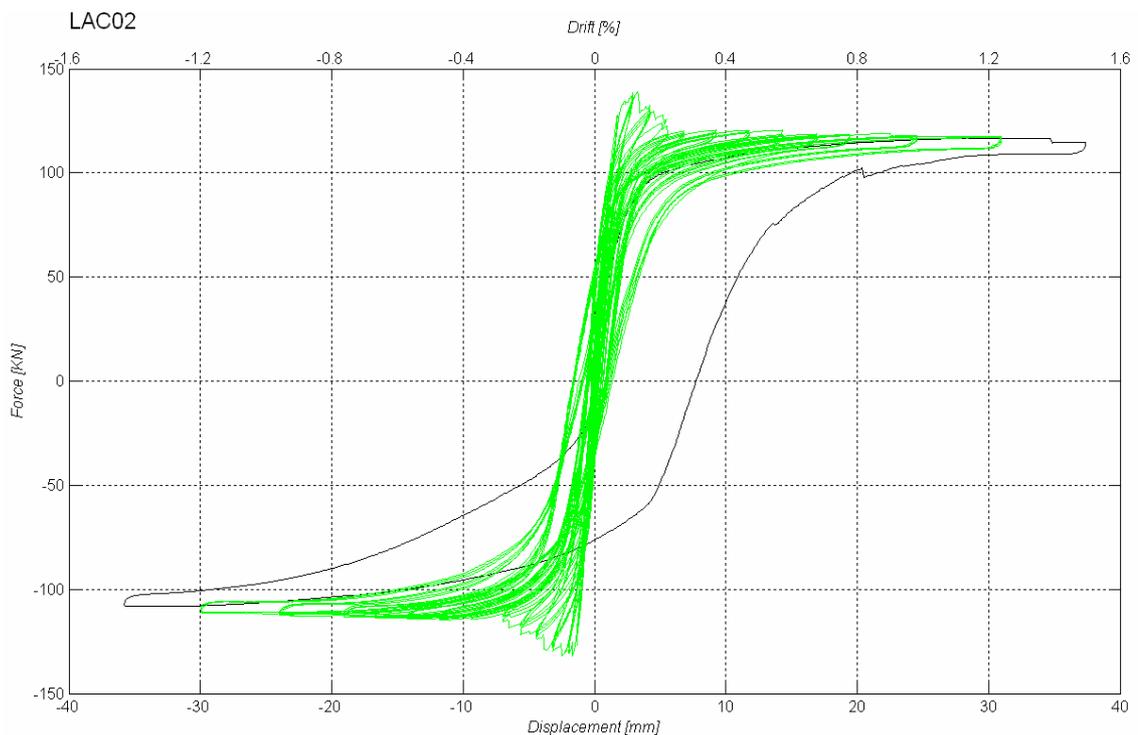
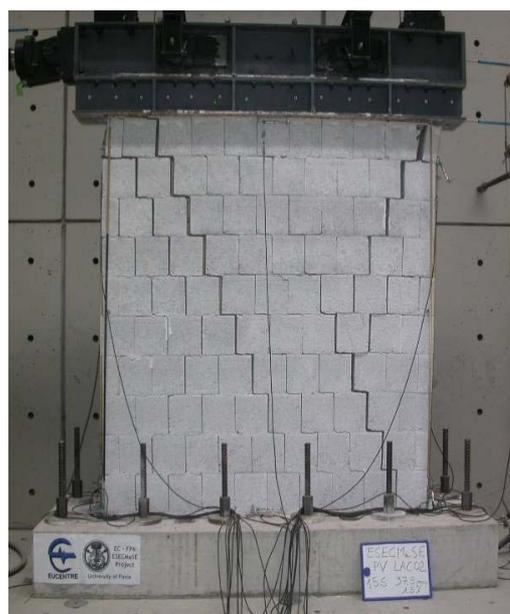
Wall LAC02 had the same characteristics of wall LAC01 with thin layer mortar bedjoints. At a horizontal displacement of about  $\pm 12.5$  mm the opening of the unfilled head joints was evident. Cracking of bedjoints concurred to form a system of stepped diagonal cracks along the wall. These cracks closed during unloading. The hysteresis cycles showed low energy dissipation. Small cracks in the units caused, at small level of drift (less than 0.2%), a slight strength degradation. The test was interrupted at a drift of 1.50% since large damage occurred in particular because very wide cracks occurred in the vertical joints.

Figure 41 Wall LAC02. Thin layer bedjoints, unfilled headjoints,  $l=2.50$  m,  $\sigma_v=0.50$  MPa

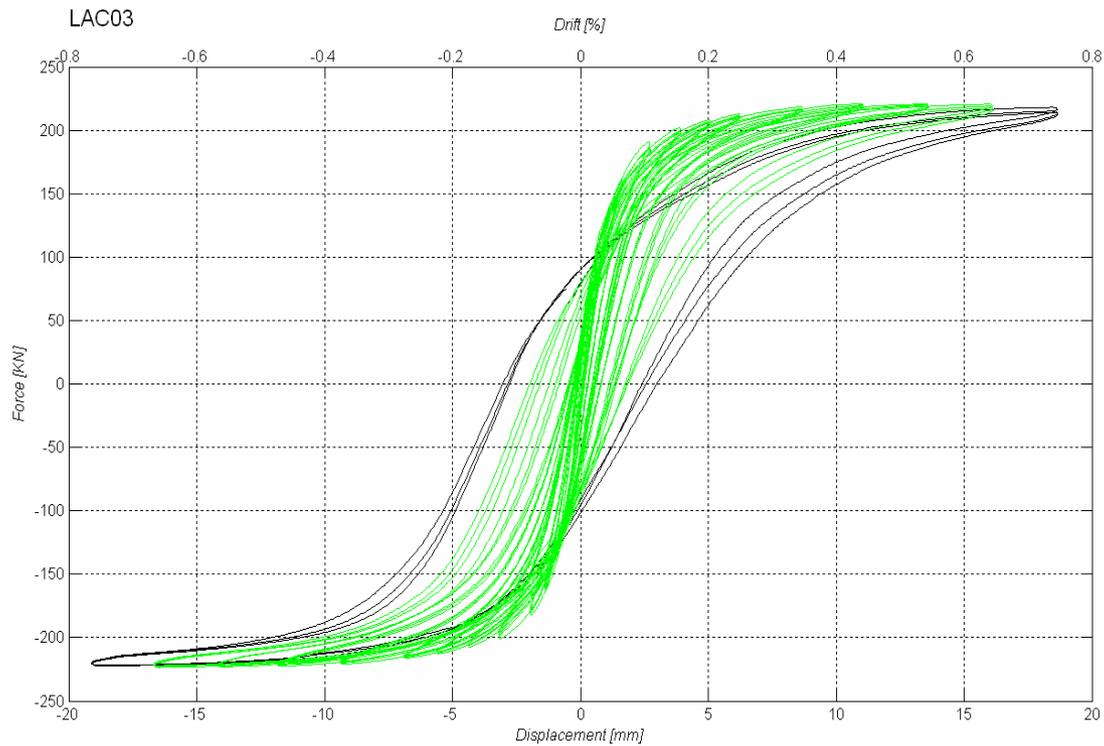
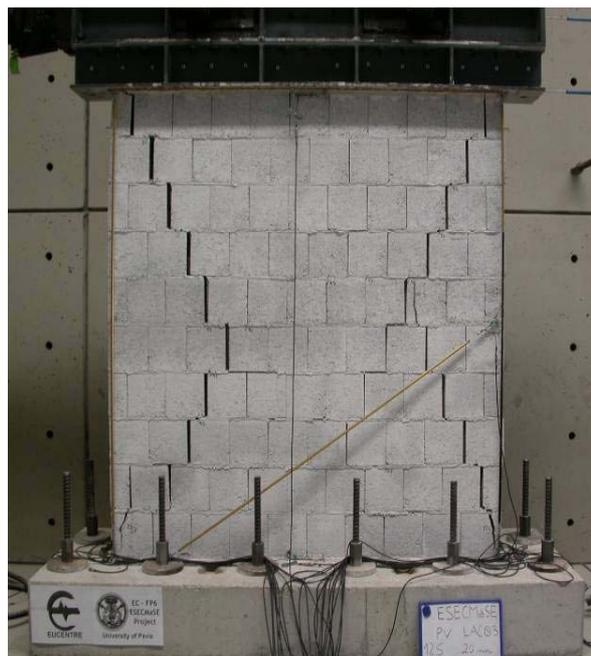
Wall LAC03 had the same characteristics of wall LAC01 with higher vertical stress (1.0 MPa). Cracking of bedjoints concurred to form a system of stepped diagonal cracks along the wall. These cracks closed during unloading. The hysteresis cycles showed low energy dissipation up to a drift level of 0.5% when the failure of the two bottom corner units occurred and energy dissipation was developed. However, no strength degradation was evident. The test was interrupted at about 19 mm since large damage occurred.

Figure 42 Wall LAC03. G.P. bedjoints, unfilled headjoints,  $l=2.50$  m,  $\sigma_v=1.00$  MPa

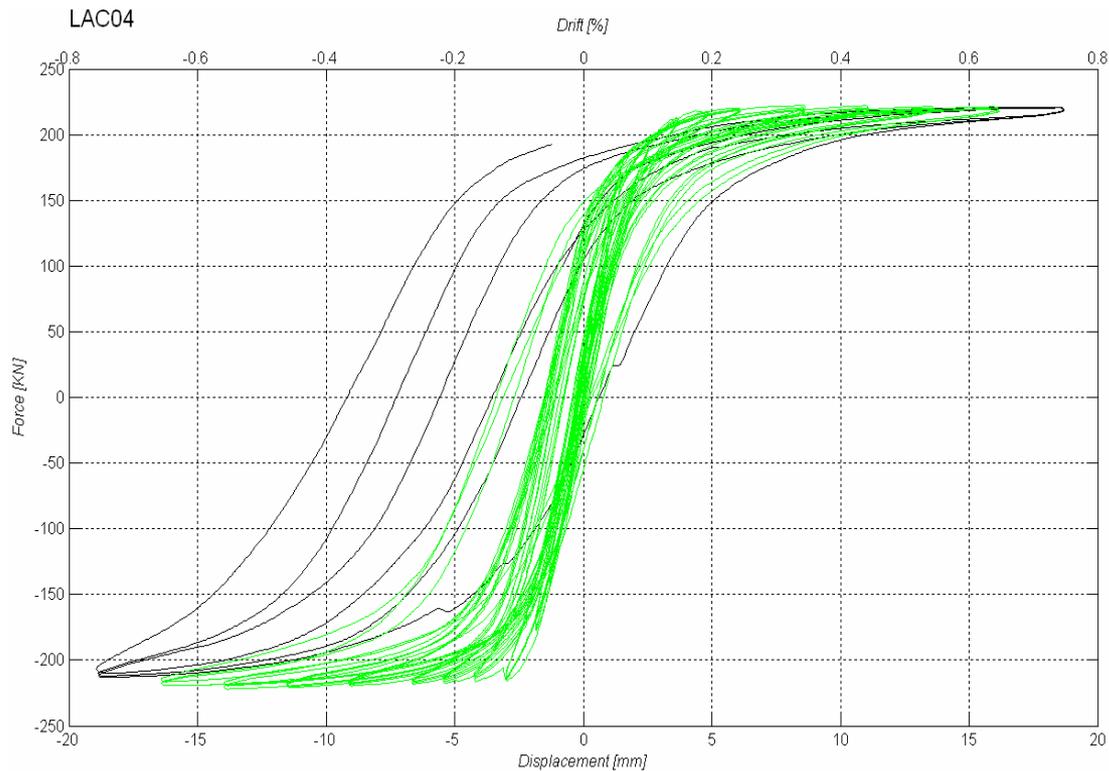
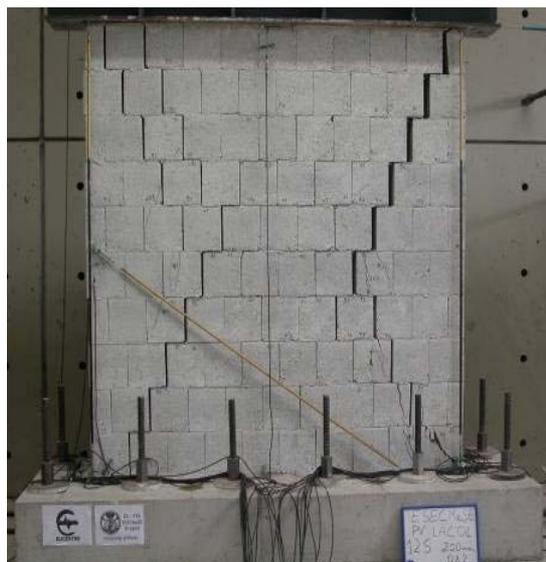
In wall LAC04 cracking of bedjoints and headjoint concurred to form a system of stepped diagonal cracks along the wall. These cracks closed during unloading. The hysteresis cycles showed low energy dissipation up to a drift level of 0.6% when diagonal cracks of the two bottom corner units occurred and energy dissipation was developed. No strength degradation was evident. As in the wall LAC03, the test was interrupted at about 19 mm since large damage occurred.

Figure 43 Wall LAC04. Thin layer bedjoints, unfilled headjoints,  $l=2.50$  m,  $\sigma_v=1.00$  MPa

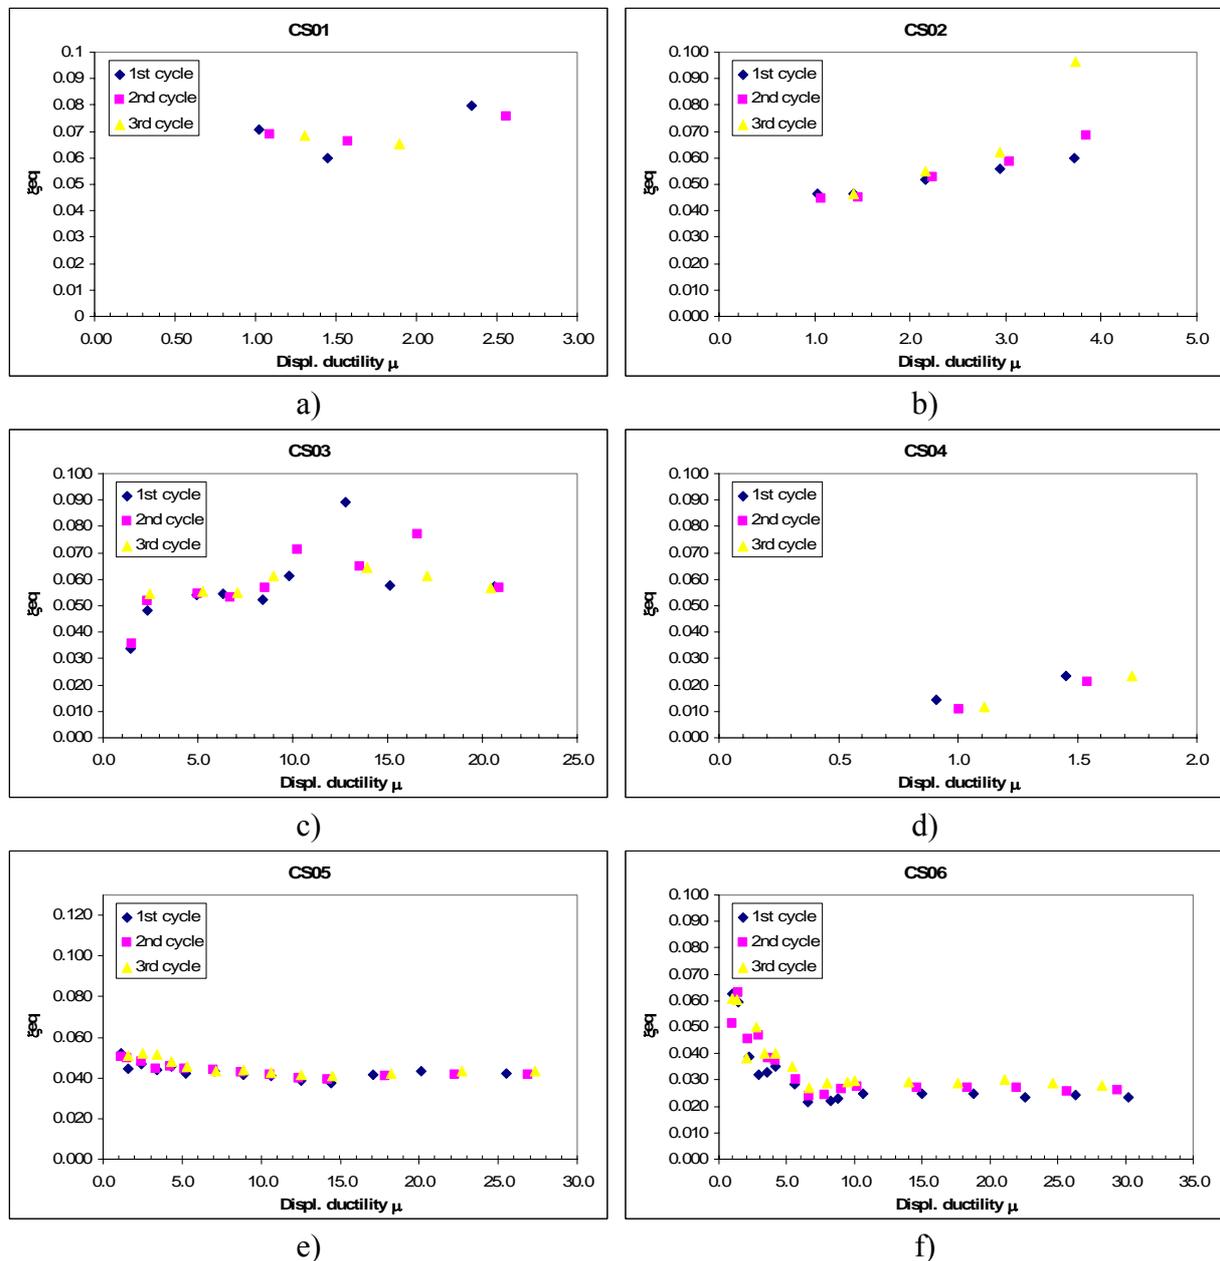
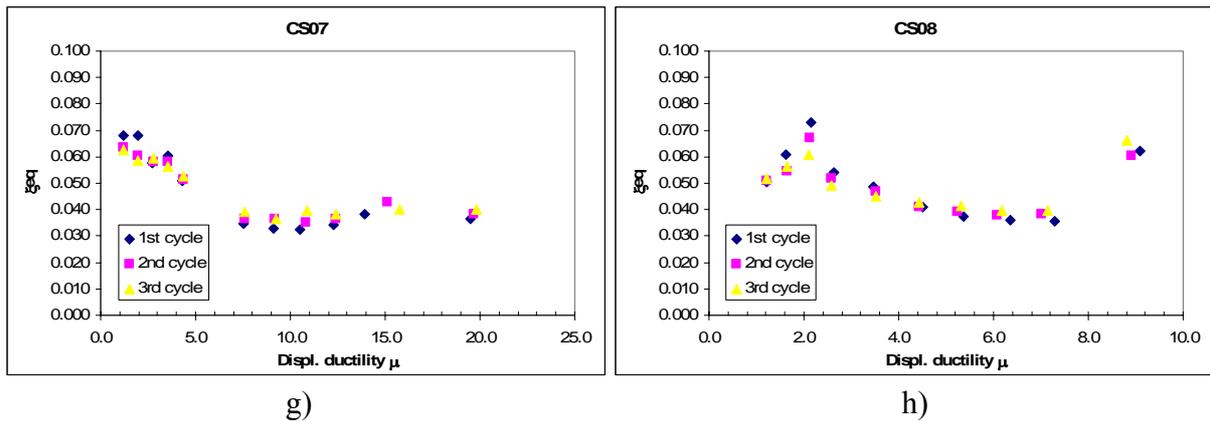
Figure 46. Equivalent viscous damping ratio calculated from the hysteresis loop as a function of ductility ( $\mu = \delta / \delta_e$ ), where  $\delta$  is the maximum displacement of the cycle. Walls CS01-CS08

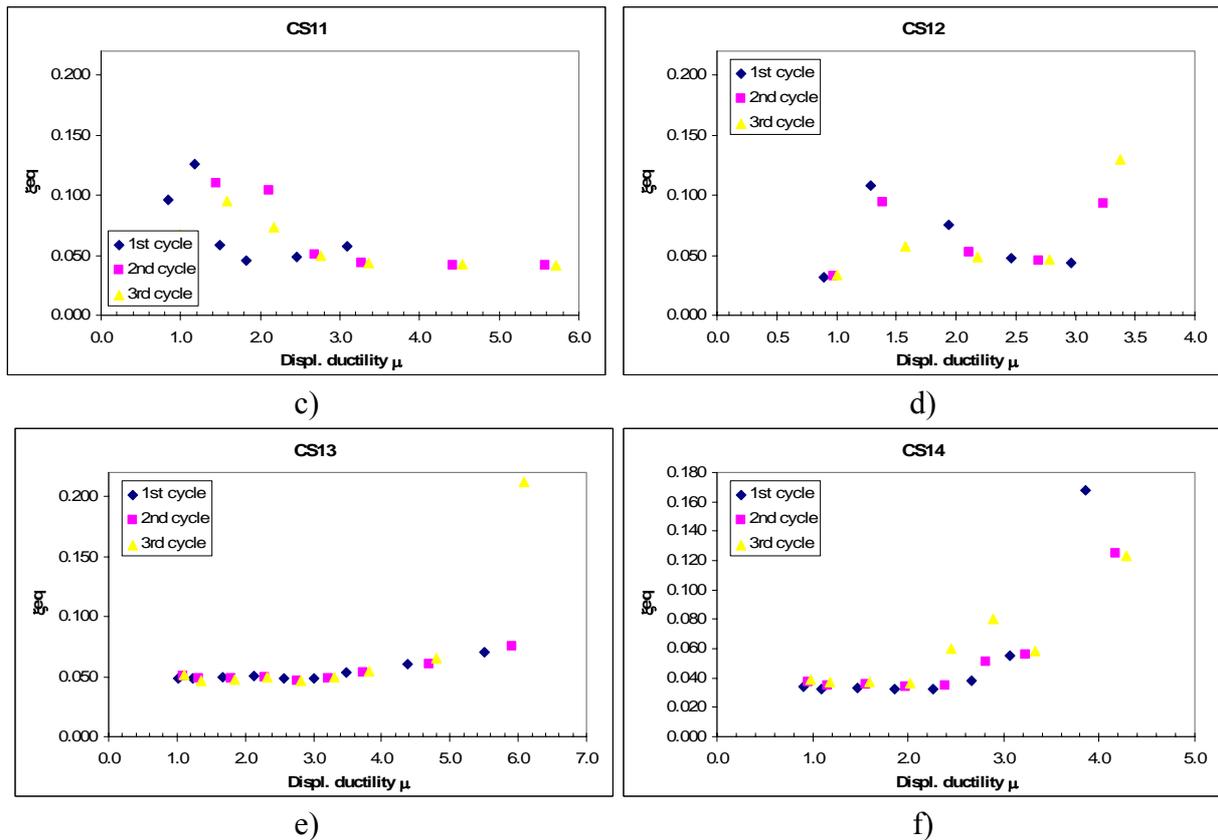
Figure 47. Equivalent viscous damping ratio calculated from the hysteresis loop as a function of ductility. Walls CS09-CS14

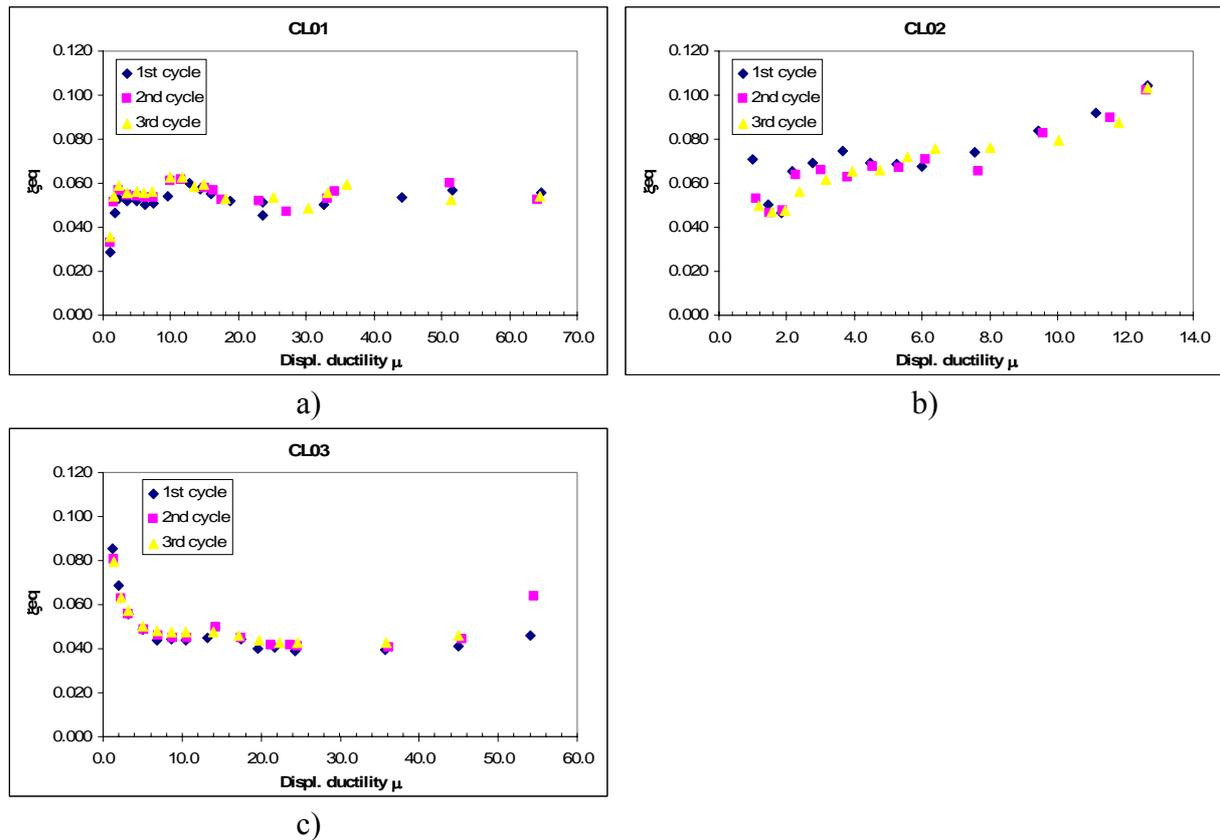
Figure 48. Equivalent viscous damping ratio calculated from the hysteresis loop as a function of ductility. Walls CL01-CL03

The cycles of these walls have low dissipativity. All these walls failed in flexure.

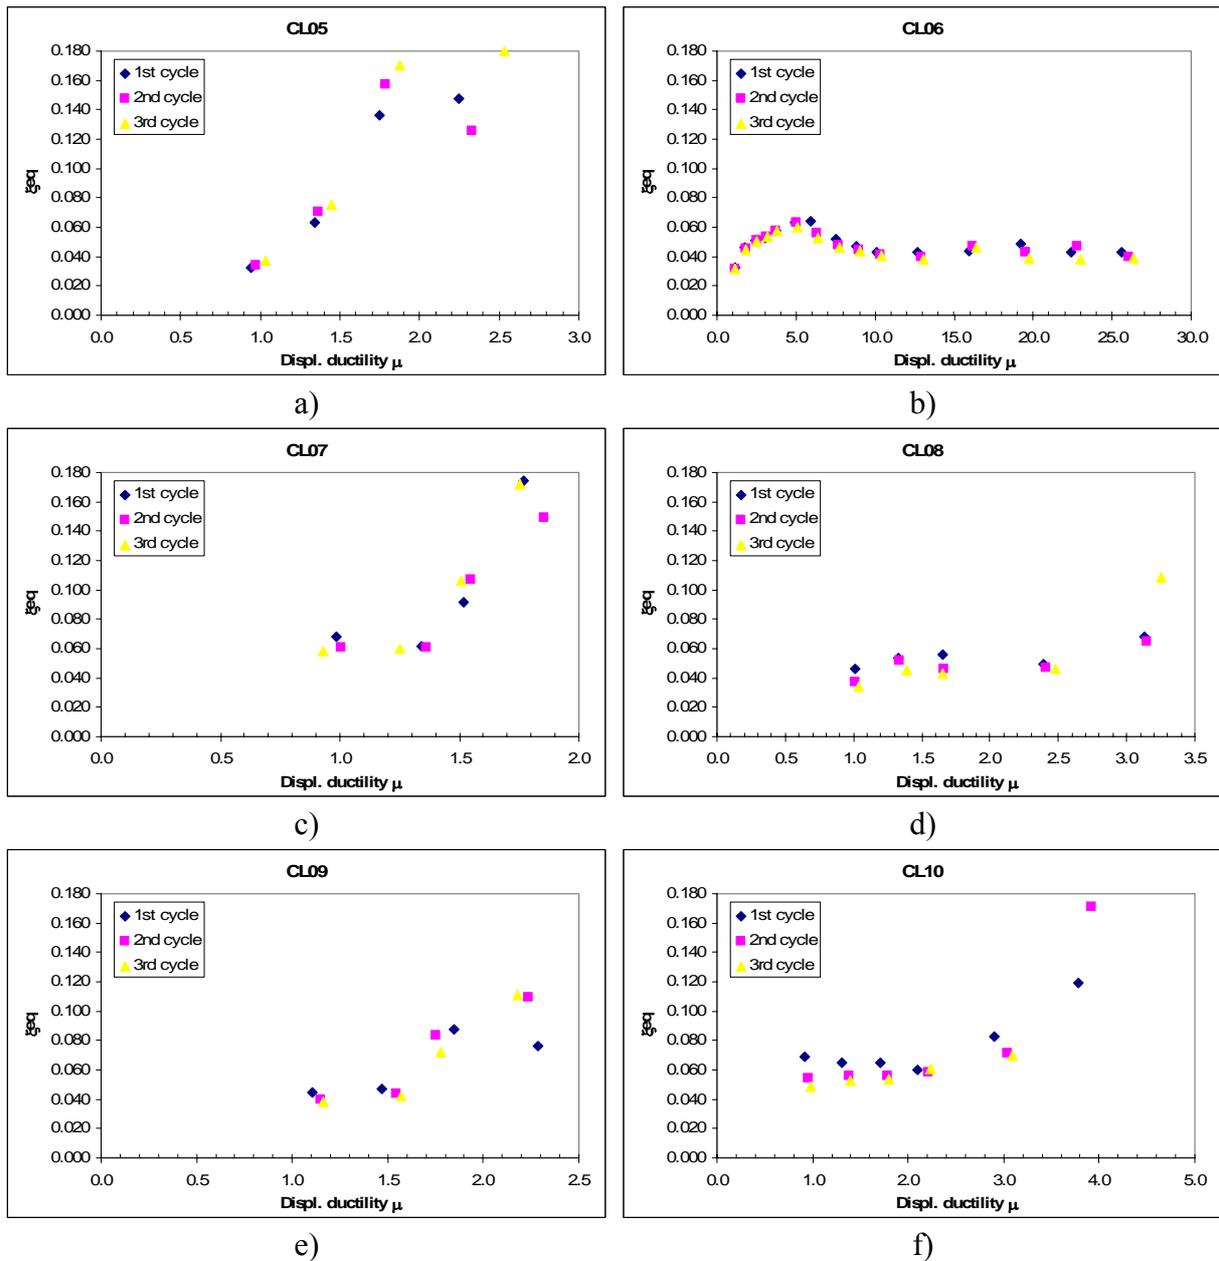
Figure 49. Equivalent viscous damping ratio calculated from the hysteresis loop as a function of ductility. Walls CL05-CL10
