**ESECMaSE**

**Enhanced Safety and Efficient Construction of Masonry Structures in Europe**

**D 7.1c Test results on the behaviour of masonry  
under static cyclic in plane lateral loads**

University of Pavia  
Department of Structural Mechanics  
Via Ferrata, 1  
27100 Pavia, Italy

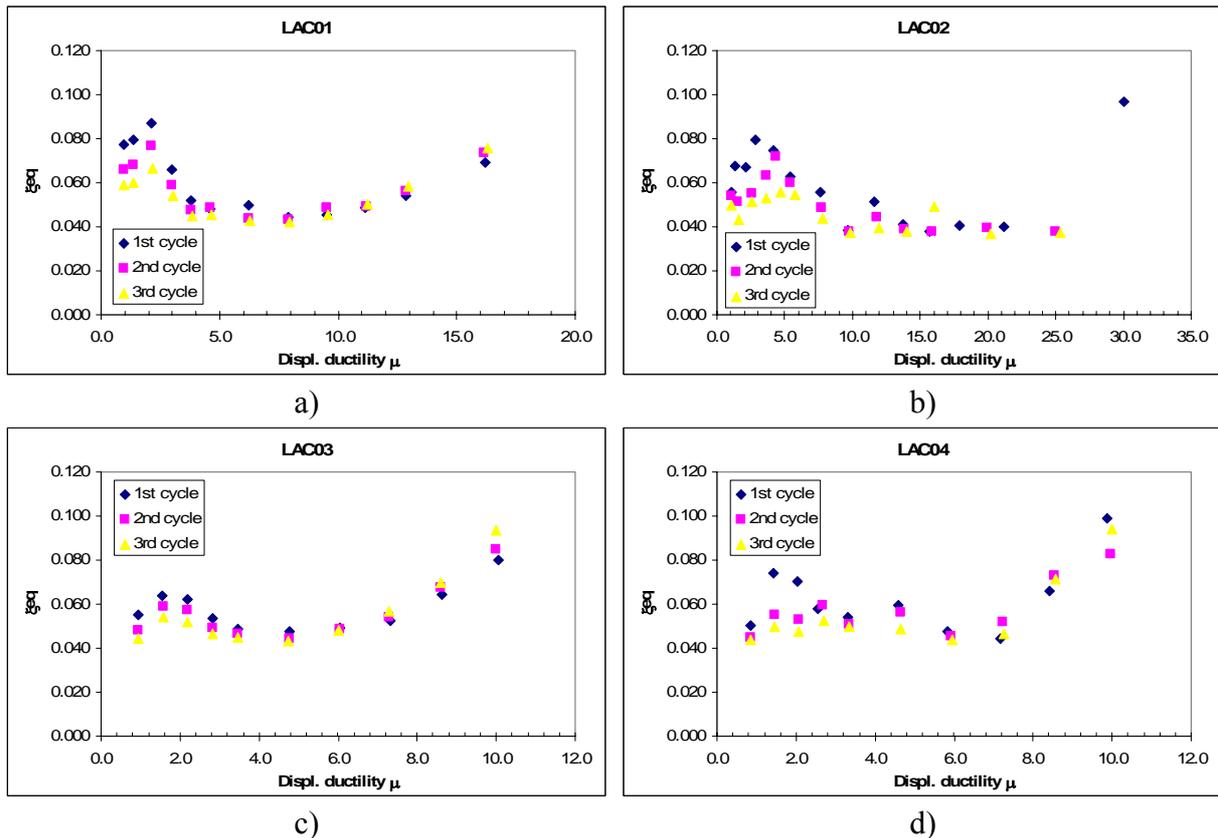
Figure 50. Equivalent viscous damping ratio calculated from the hysteresis loop as a function of ductility. Walls LAC01-LAC04
