ESECMaSE

Enhanced Safety and Efficient Construction of Masonry Structures in Europe

D 8.3 Earthquake tests and analysis of the experimental results

Armelle Anthoine and Philippe Capéran
European Laboratory for Structural Assessment (ELSA)
Joint Research Centre of the European Commission
21020 Ispra (VA)

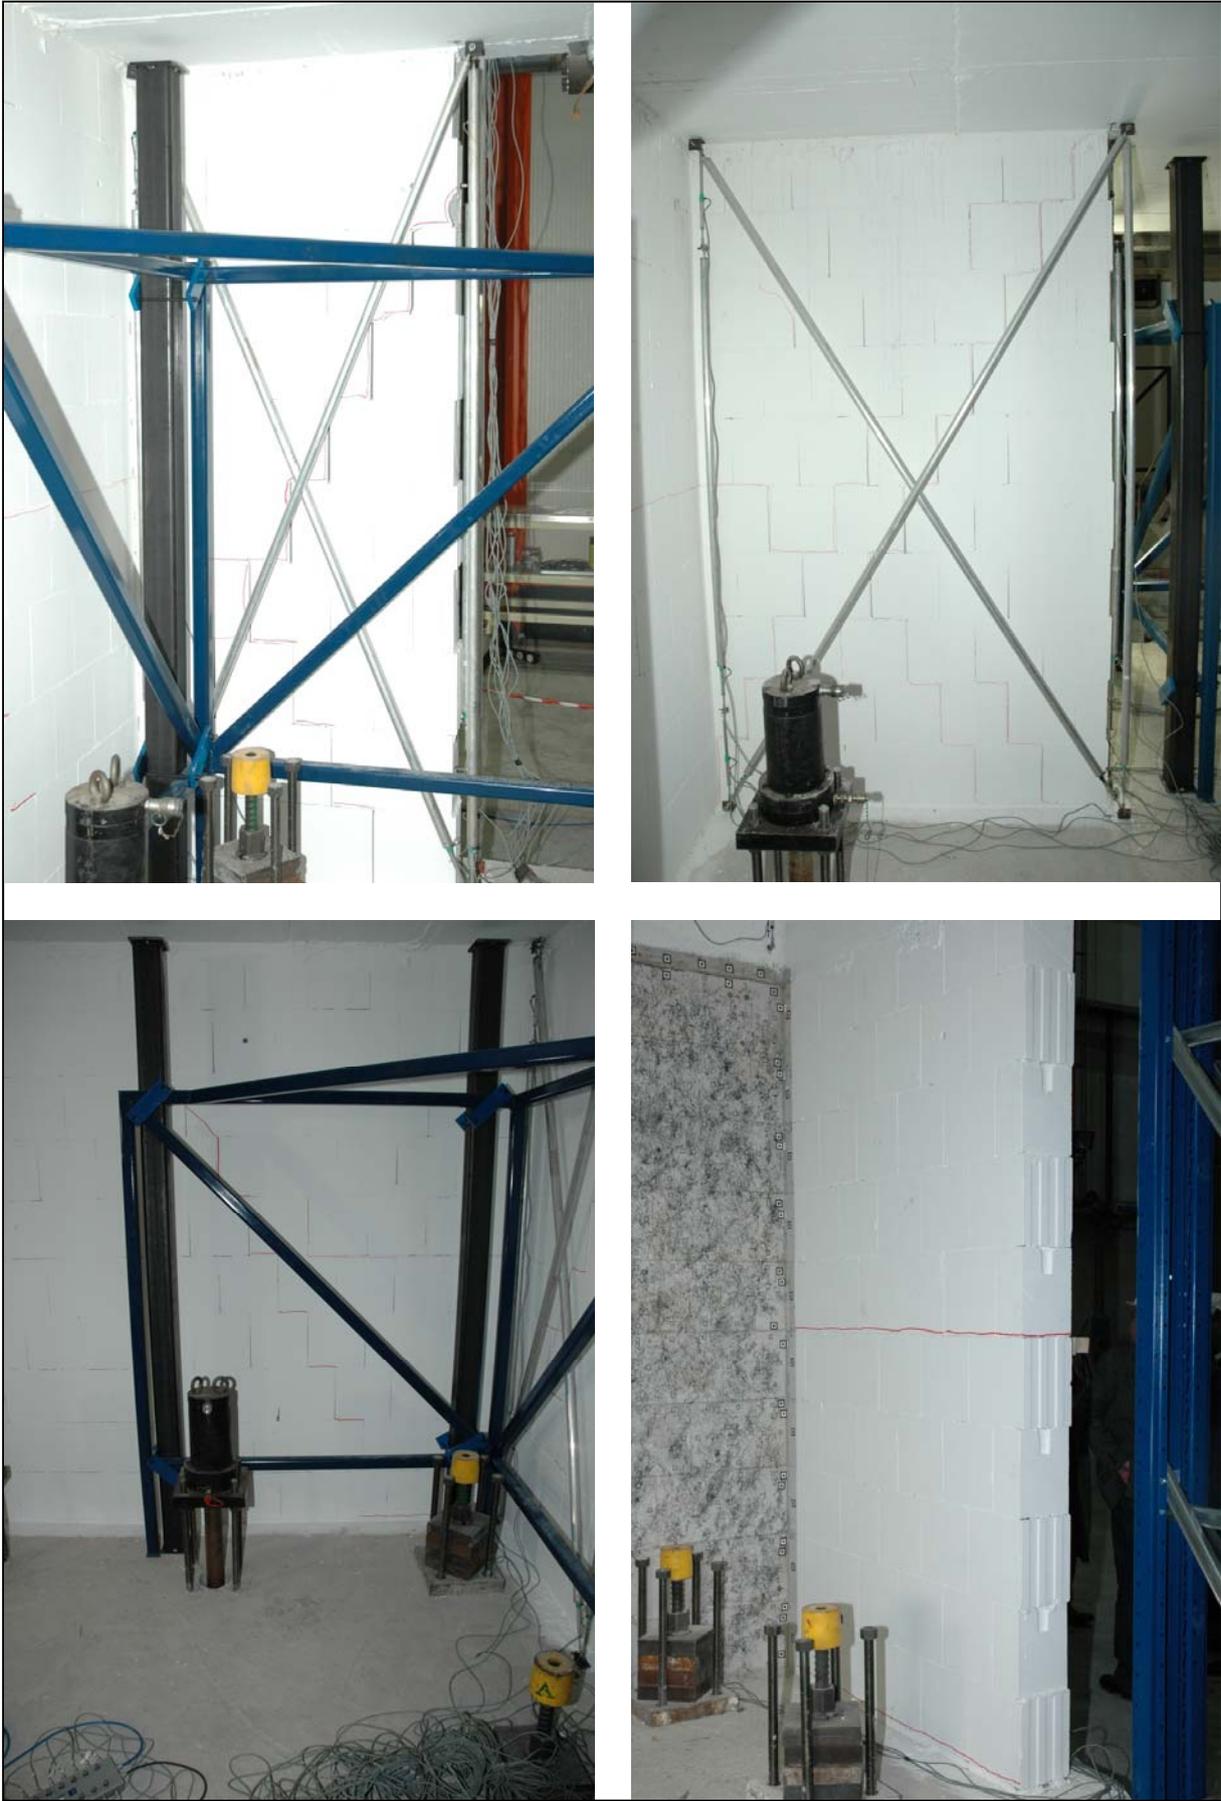
Figure 8: First relevant damages after the 0.12g test

The first significant damages appeared during the 0.12g test (Figure 8): Large stepwise cracks formed in the west slender wall of the ground floor and, in both long transversal walls, a horizontal crack opened at mid-height of the first level: on the east side in correspondence to the main shear wall, on the west side in correspondence to the slender wall. After an accurate inspection, threadlike stepwise cracks were also detected in the main shear wall of the ground floor. The top displacement reached 16.6mm and the shear-drift curves of the first level were markedly hysteretic owing to the friction along the stepwise cracks.

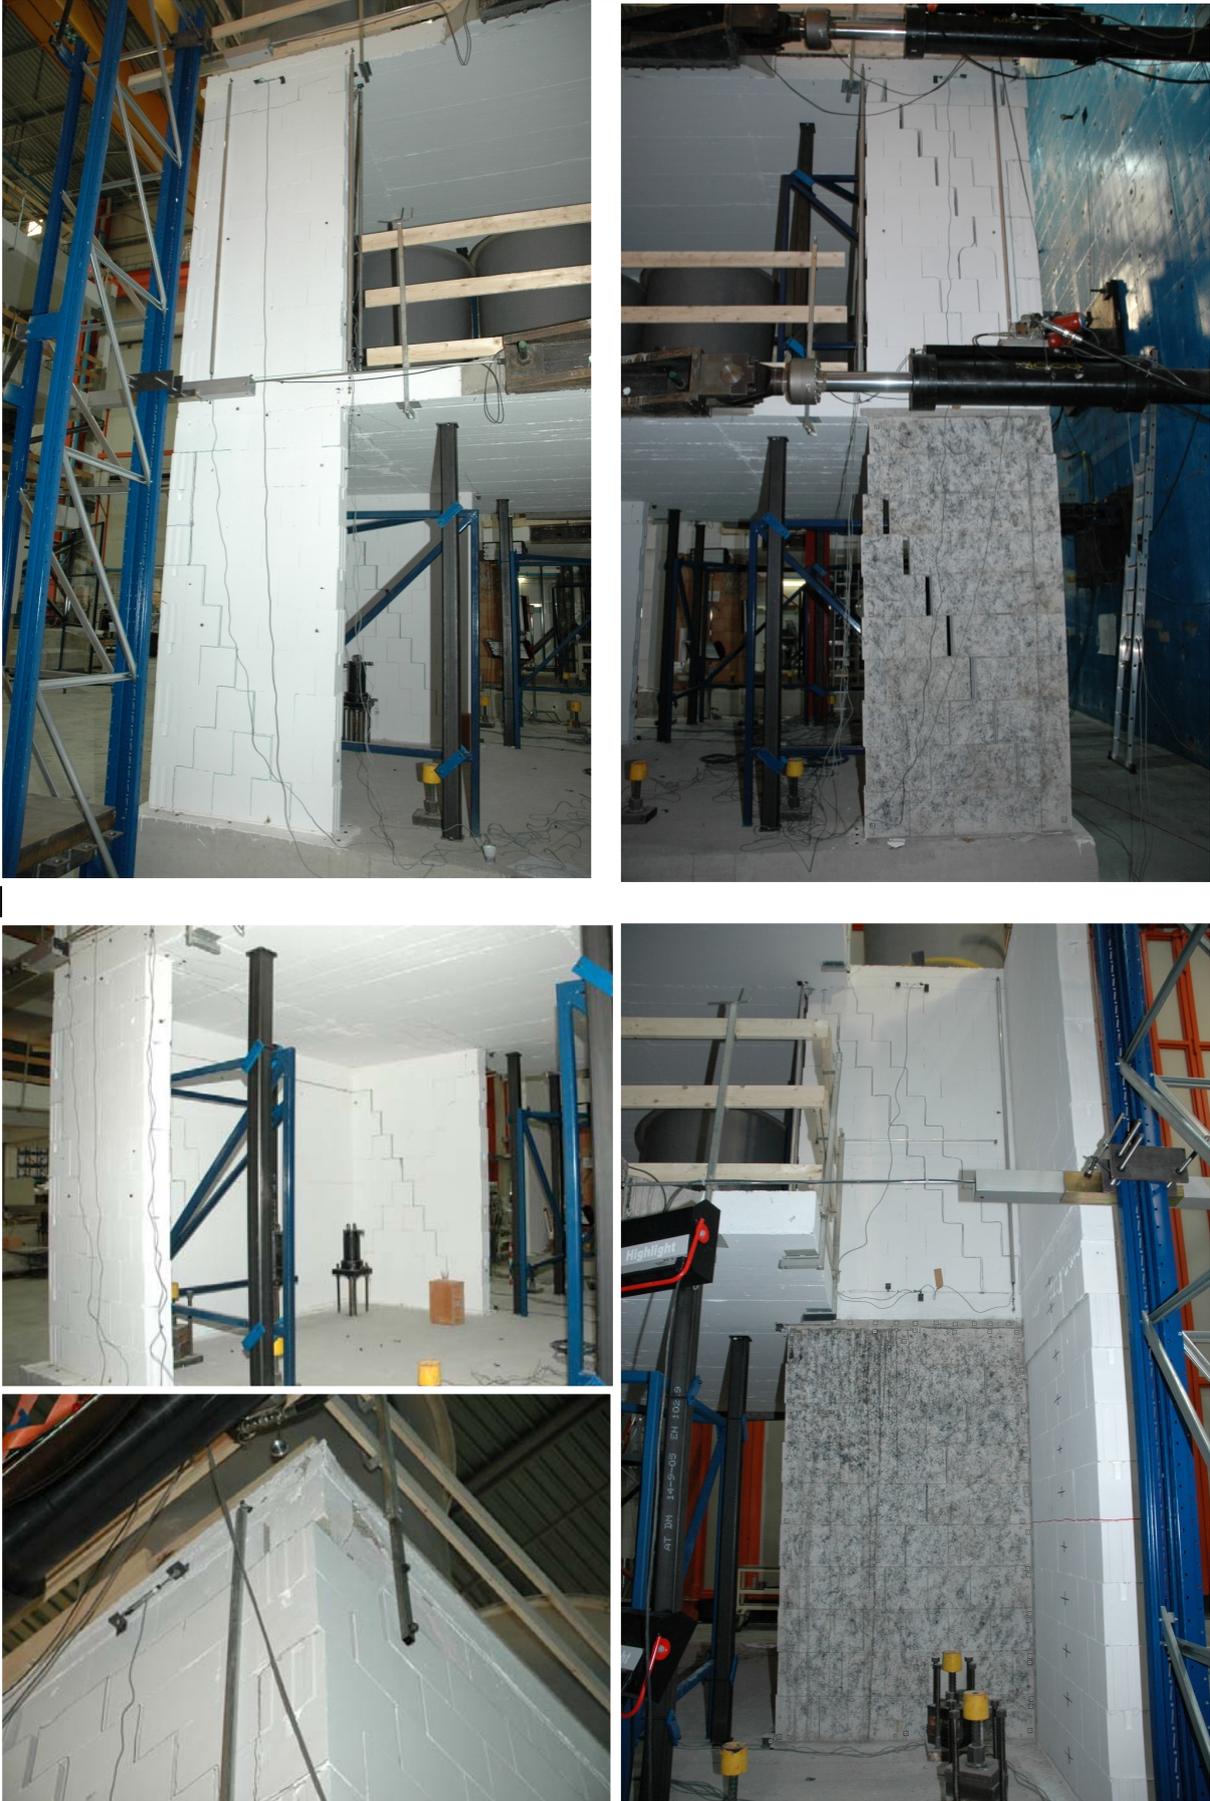
Figure 9: Damages in the calcium silicate specimen after the final test (0.20g)

Very few new cracks appeared during the test at 0.18g although the top displacement reached a value of 51.1mm. Conversely, the last test at 0.20g was characterised by a severe cracking (also through the units) of the north-west top corner of the specimen, including the slender wall as well as the neighbouring portion of the transversal wall (Figure 9). The top displacement reached 70.4 mm.

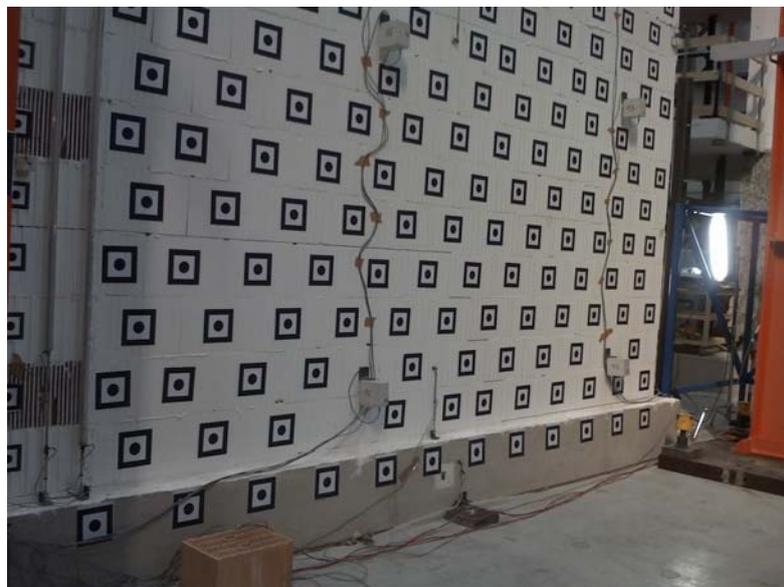
Figure 13: Flexural cracks on the east transversal wall during the 0.12g test

The first few noticeable damages appeared during the 0.12g test (maximum top displacement of 22.6mm): a horizontal flexural crack opened at mid-height of the first level on the east transversal wall in correspondence to the slender wall. This crack was prolonged by a stepwise crack downwards in correspondence to the main shear wall and was then connected to the existing flexural crack at the base of the wall (Figure 13). Threadlike stepwise cracks were also detected in the east slender wall of the ground floor but their exact extension was difficult to assess (Figure 14, left). Conversely, no damage could be seen in the main shear wall except on the boundaries: cracks had occurred in the bottom joint as well as the lateral vertical joint.

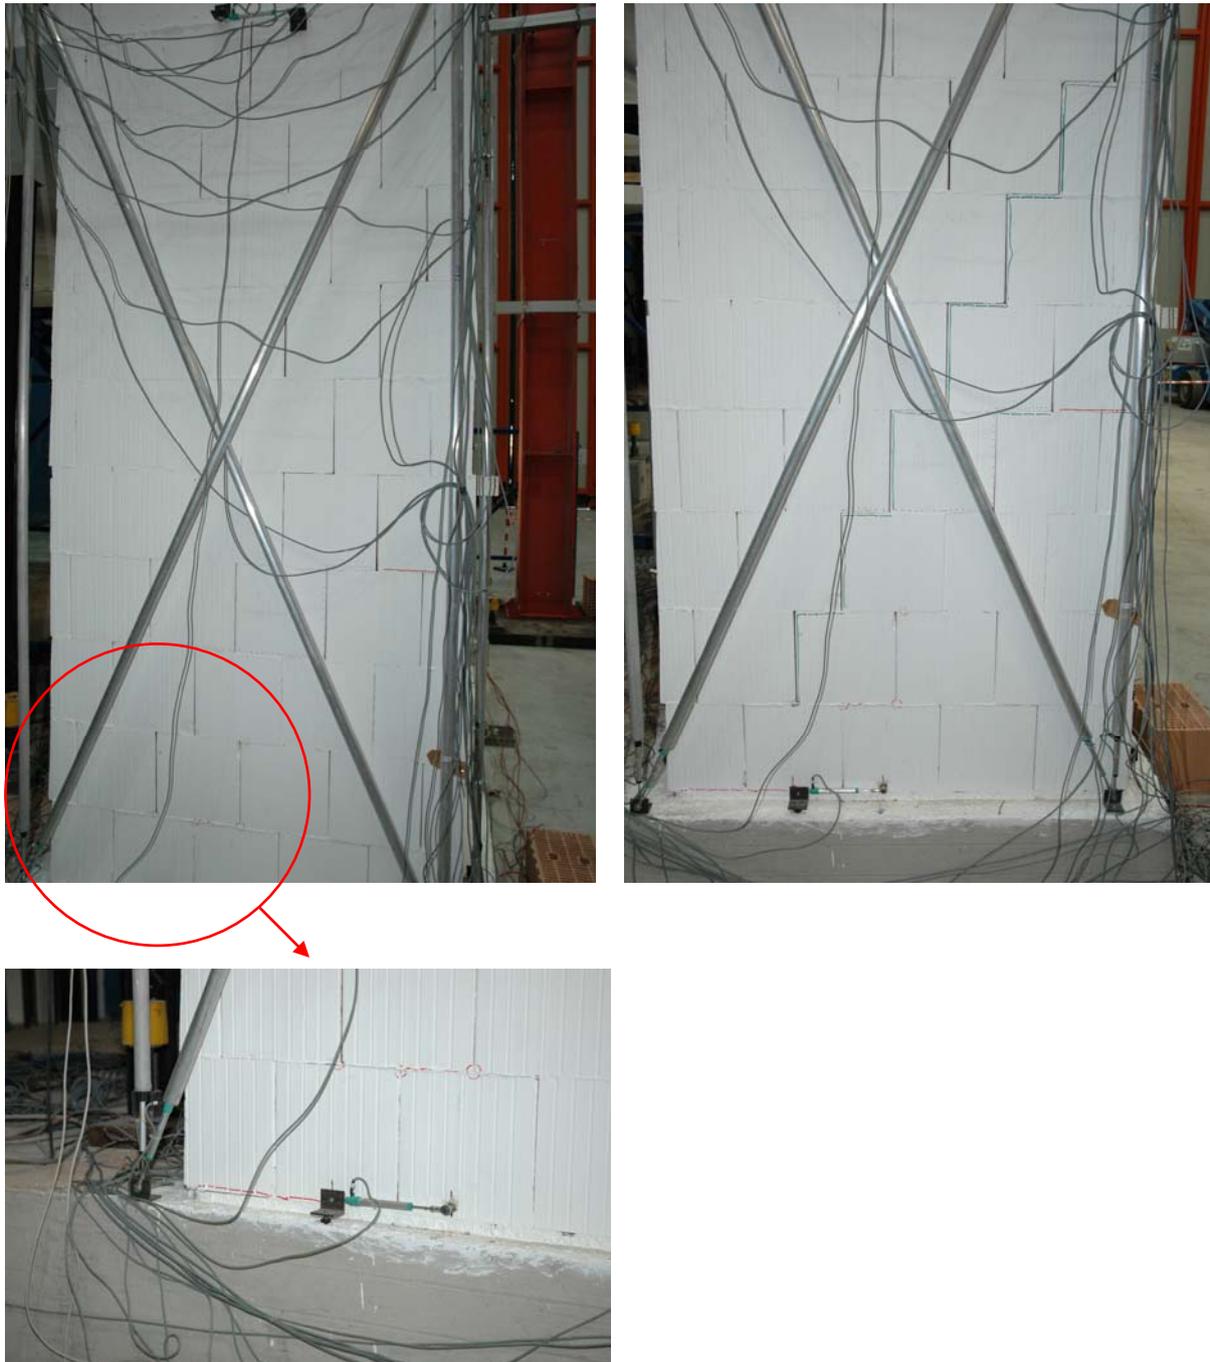
Figure 14: Cracks in the east slender wall of the ground floor after the 0.12g test (left) and the 0.14g test (right)

During the following test (0.14g), the top displacement reached 28.0mm. A stepwise crack fully developed in the east slender wall of the ground floor (Figure 14, right). A new horizontal flexural crack opened at mid-height of the second level on the east transversal wall

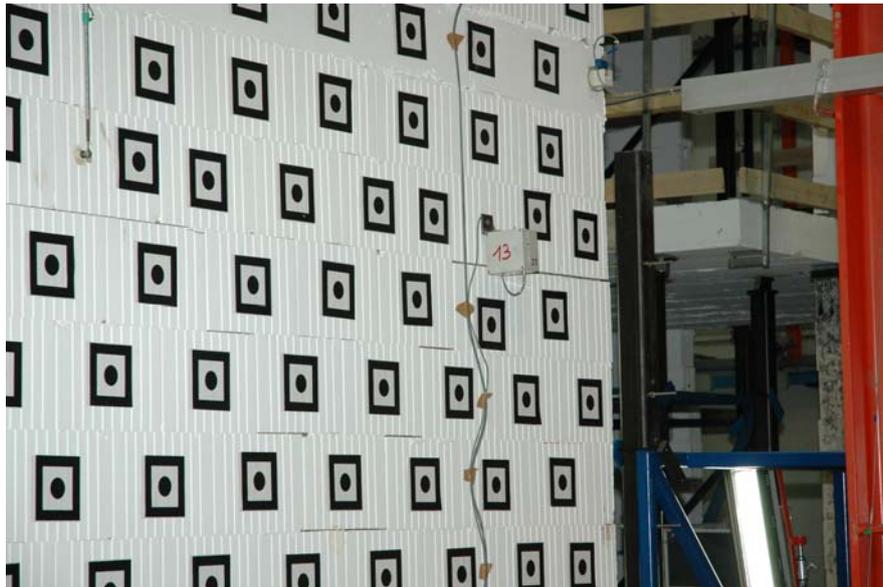
Figure 15: Flexural cracks on the east transversal wall during the 0.16g test

The test at 0.16g has been very similar to the test at 0.14g in terms of displacement amplitude (28.8mm at the top). However, new flexural cracks opened on the east transversal wall (V-shape stepwise crack in correspondence of the main shear wall visible on Figure 15). Also the junctions between the slender walls and the long transversal walls failed at both levels and several cracks appeared on the lower face of the first slab, mainly parallel to the transversal walls and passing near the corners of the shear walls.

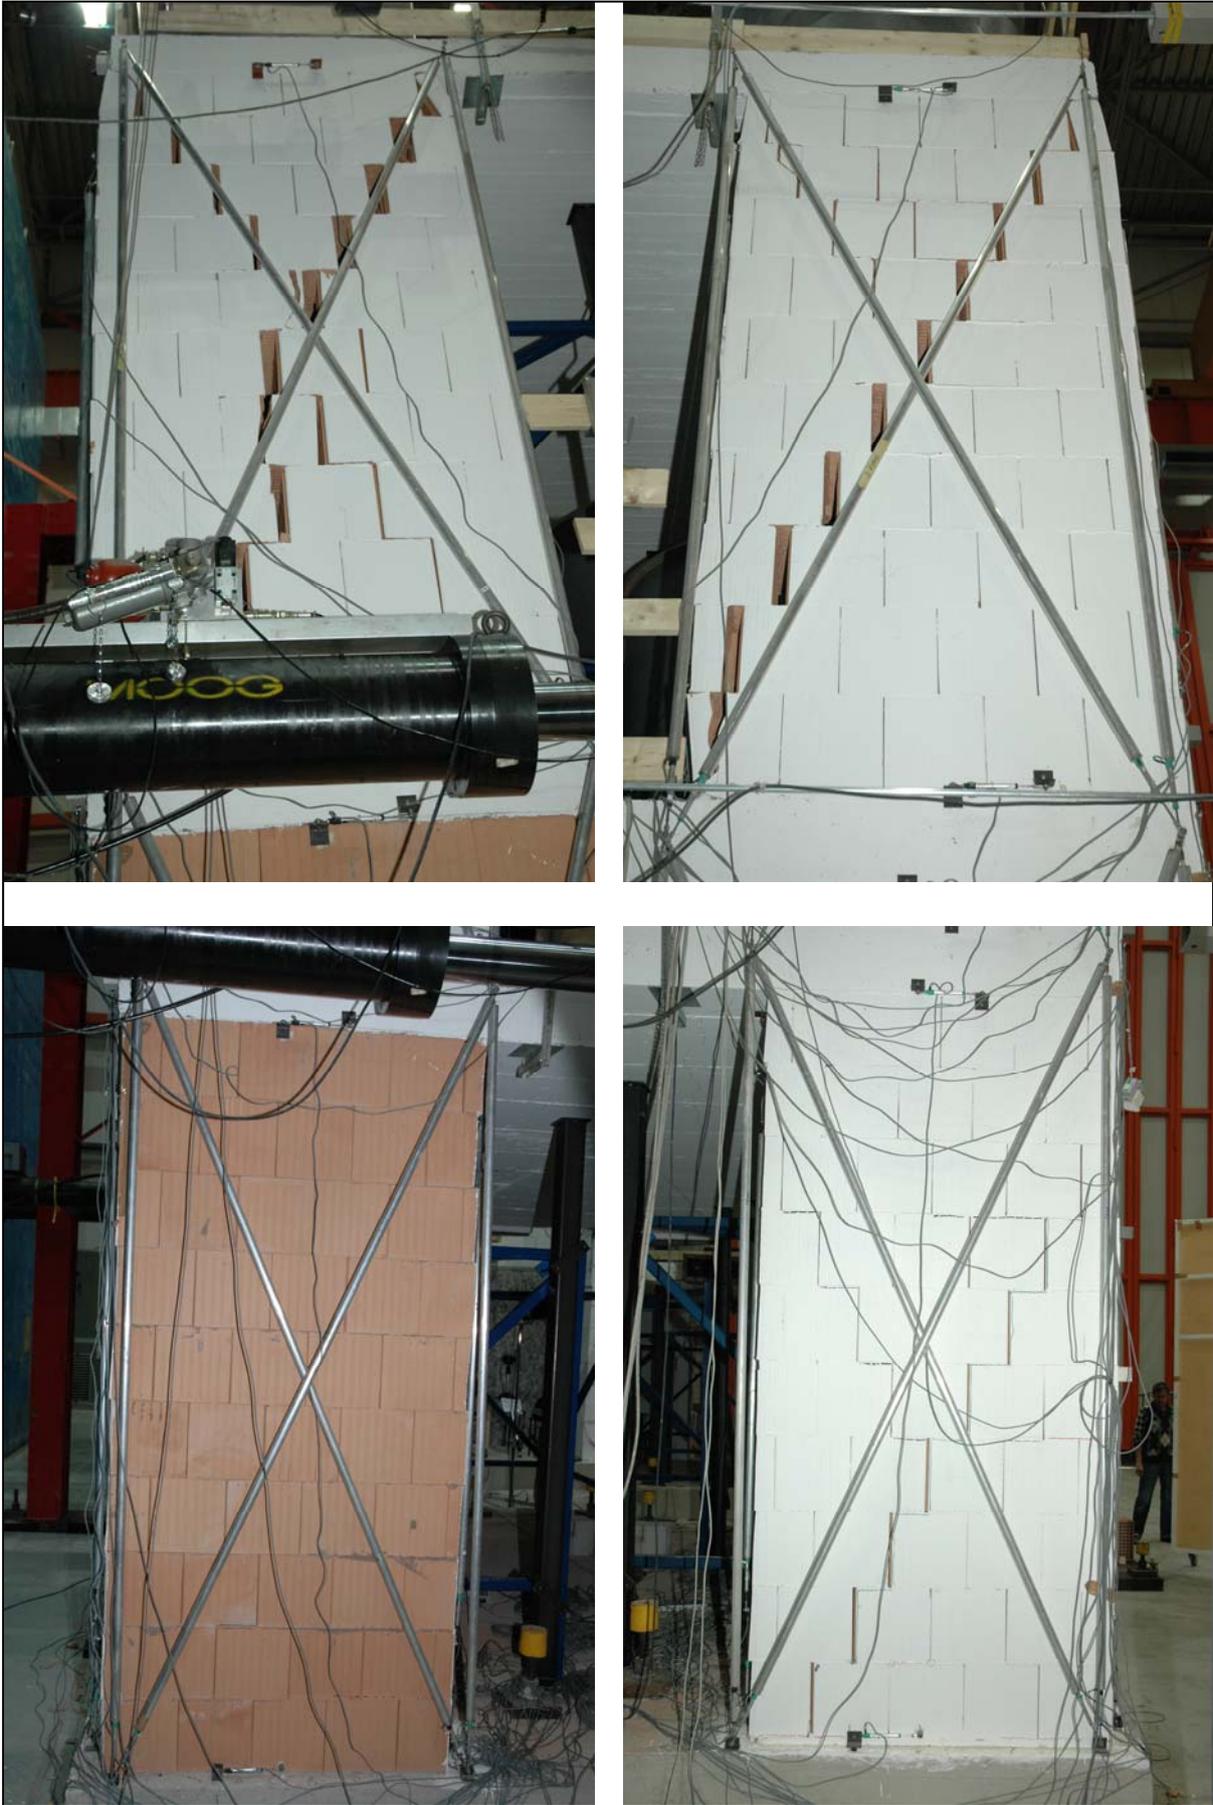
Figure 16: Damages in the slender walls after the final test (0.22g)

The last test at 0.22g (77.0 mm at the top) was characterised by a severe diagonal cracking (also through the units) of the slender walls of the upper floor (Figure 16 top). Conversely, at the same floor, the main shear wall did not suffer significant additional damage apart from a complete separation along its boundary. At the ground level, the residual opening of the existing cracks had increased and some additional cracks had formed but the load bearing capacity of the three shear walls was still satisfactory. However, given the poor residual bearing capacity of the upper slender walls, the testing sequence has then been stopped.

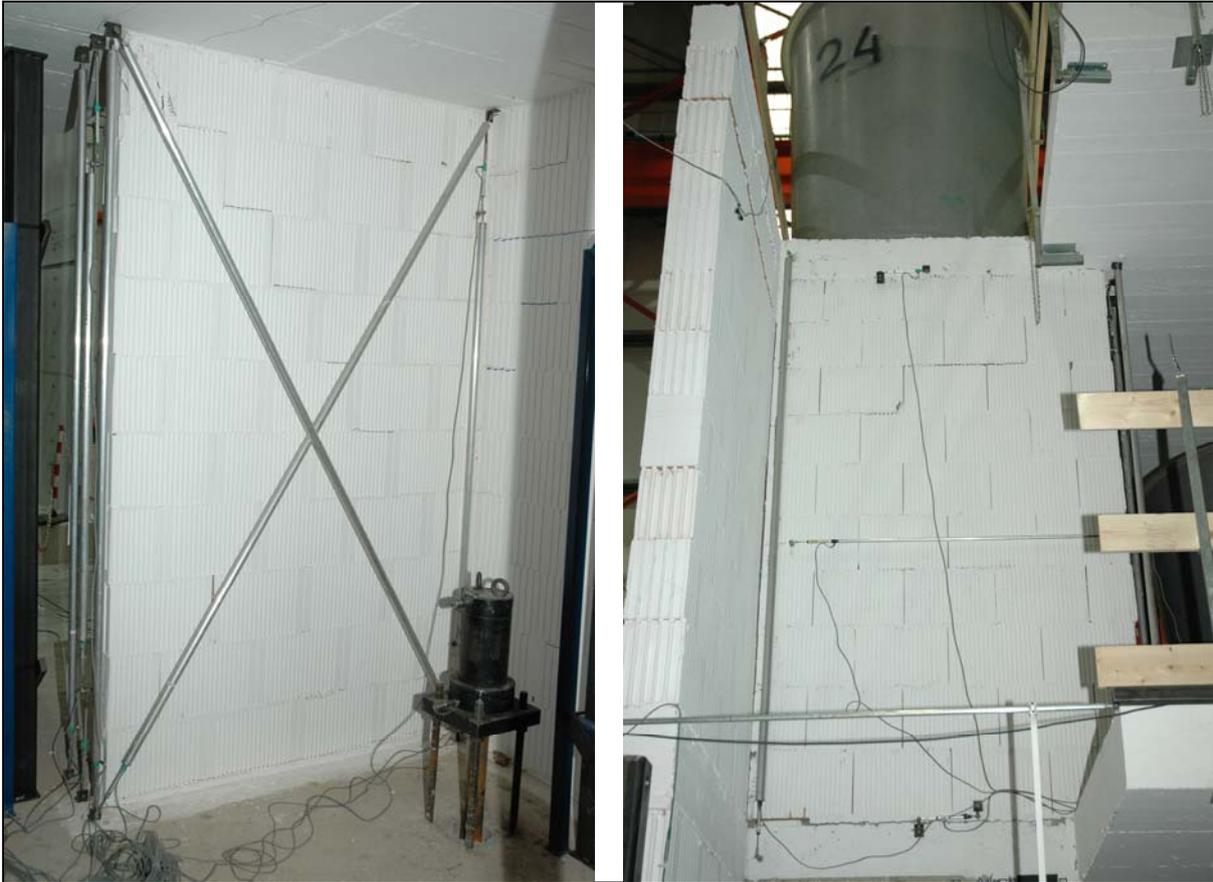
Figure 17: Damages in the main shear walls after the final test (0.22g)

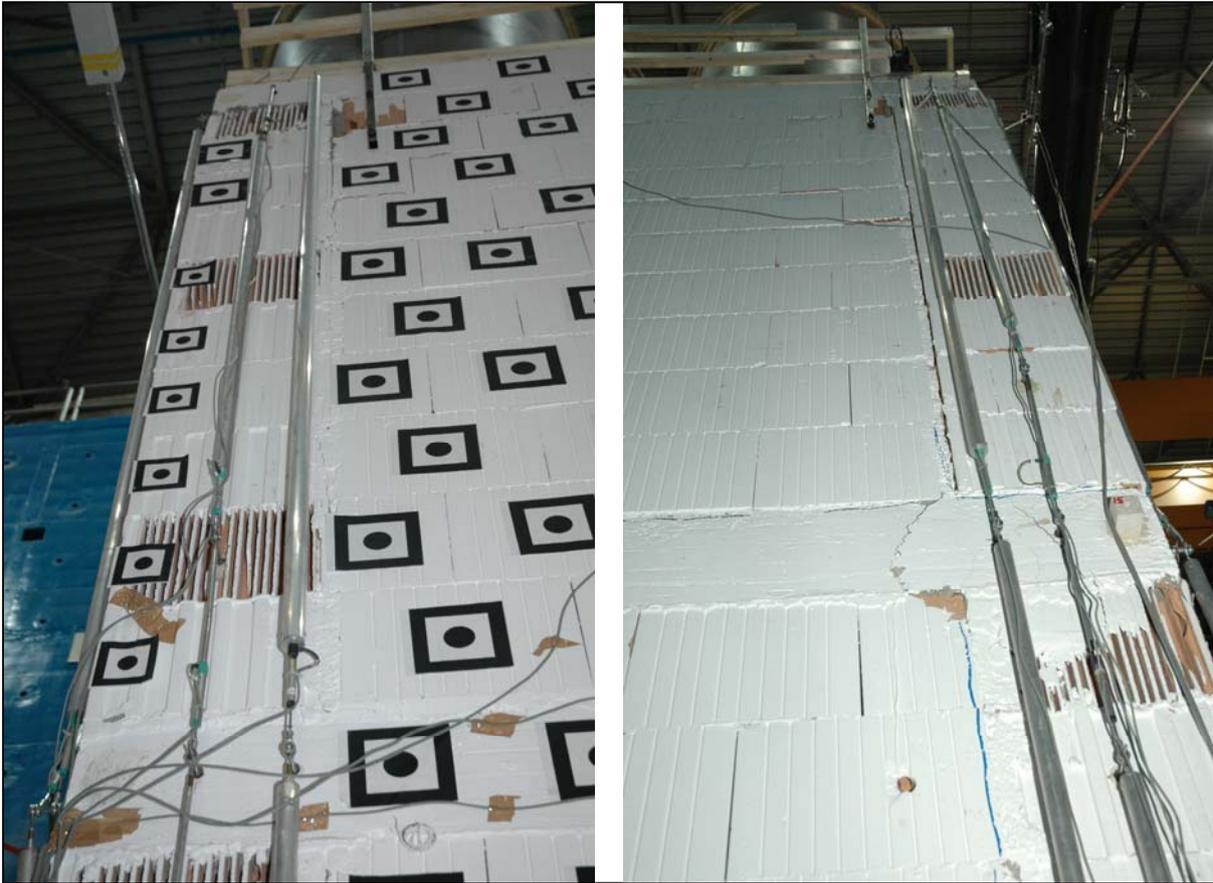
Figure 18: Damages in the slender walls junctions after the final test (0.22g)
